Vail 2010 Flood Assessment

January 27, 2011

Prepared For:
Town of Vail
Department of Public Works
1309 Elkhorn Drive
Vail, CO 81632

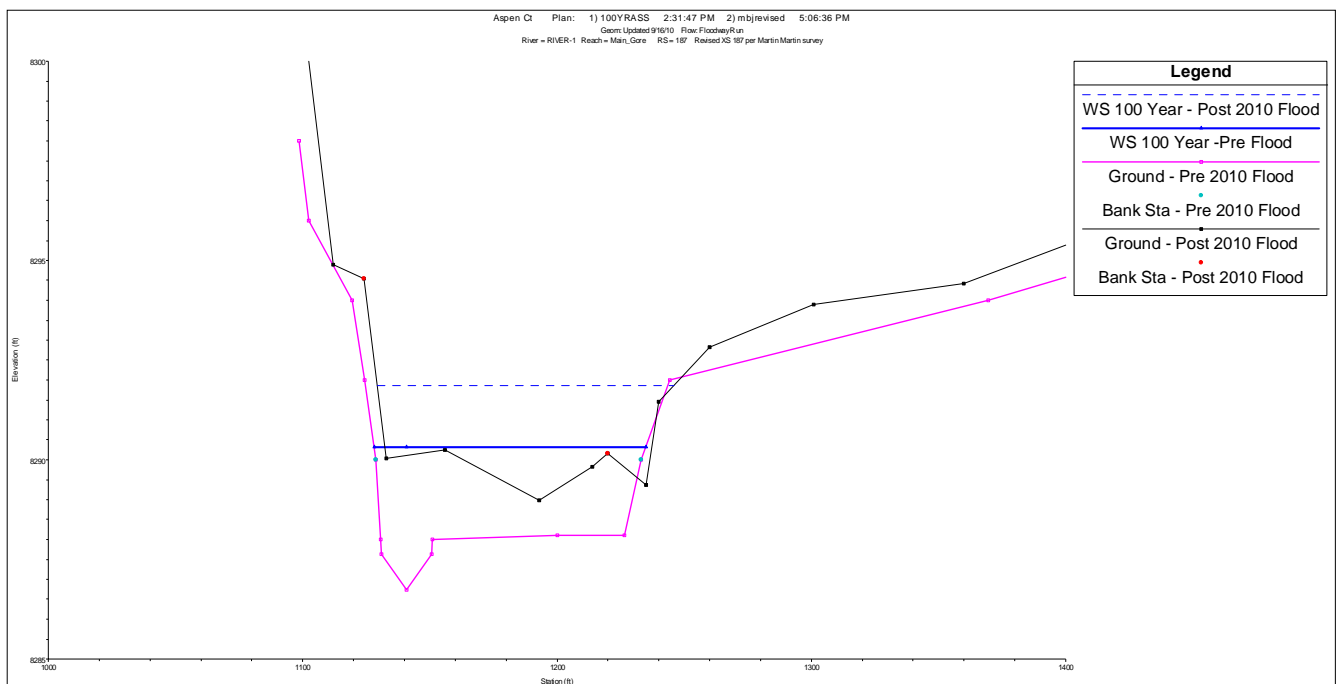
Figure 1. 1994 vs 2010 survey upstream of Aspen Court showing over 3 feet of aggradation.

Unfortunately, significant aggradation has occurred throughout the main channel of Gore Creek and may impact channel conveyance and base flood elevations as determined by FEMA. A very detailed flood study of Gore Creek was performed in 1994 - 1996 including survey of the channel bottom. A 2010 resurvey of these locations has shown up to 4 feet of channel aggradation (Figure 1). Preliminary flood modeling of the existing channel conditions shows increases in the predicted base flood elevations of up to 2 feet.

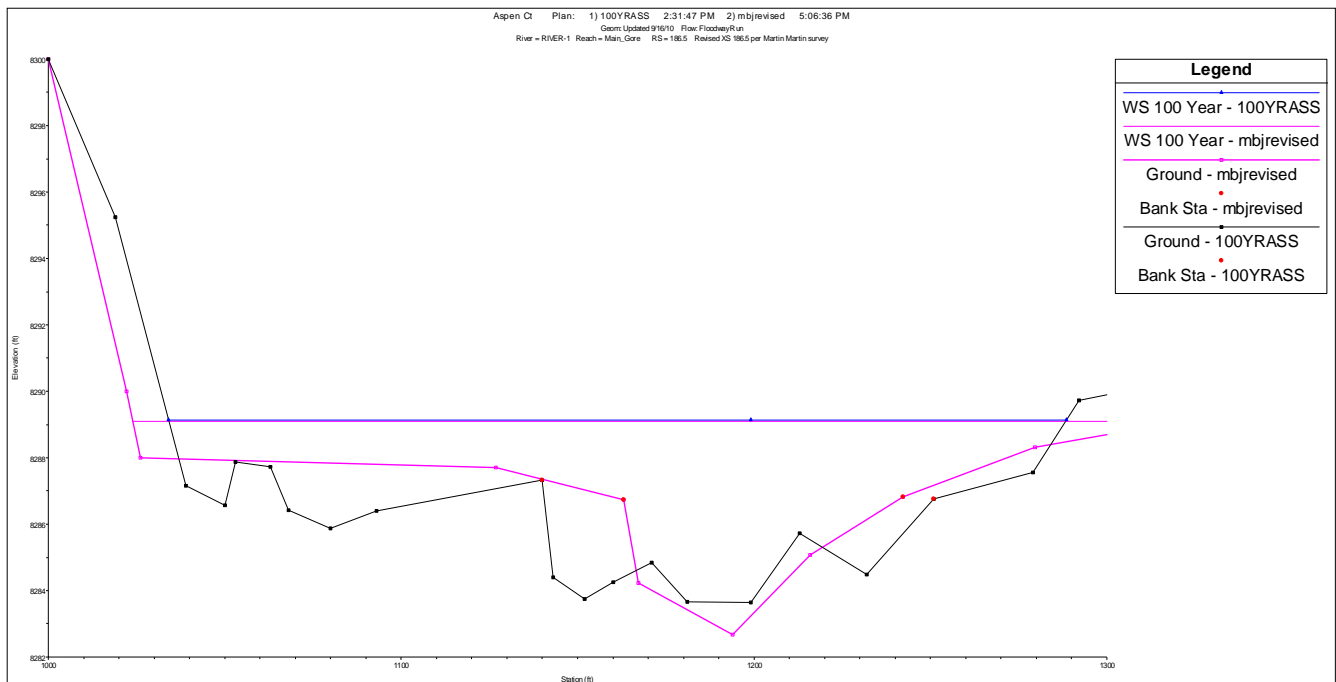
Figure 2. 1994 vs 2010 survey upstream of Aspen Court showing 43 feet of left bank erosion.

Fortunately, existing building offsets, intact riparian fringes, and open spaces have allowed for some migration of the main channel of Gore Creek. A long undeveloped segment of valley floor is intact downstream of East Vail to approximately Booth Creek. This openspace (Katsos) is very critical in absorbing the large sediment loads generated from Bighorn and Pitkin Creeks. The opportunity for sediments to aggrade in the Katsos reach reduces the amount that is transported downstream into the more developed areas of Vail. Similarly, another moderate sized riparian zone exists in the middle of the Racket Club condominiums, Upstream of Bighorn Creek. This area deposits sediments coming from upper Gore Creek and Black Gore Creek before the large sediment inputs of Bighorn and Pitkin Creeks. Booth Creek deposits largely occur along the Vail Golf Course channel.

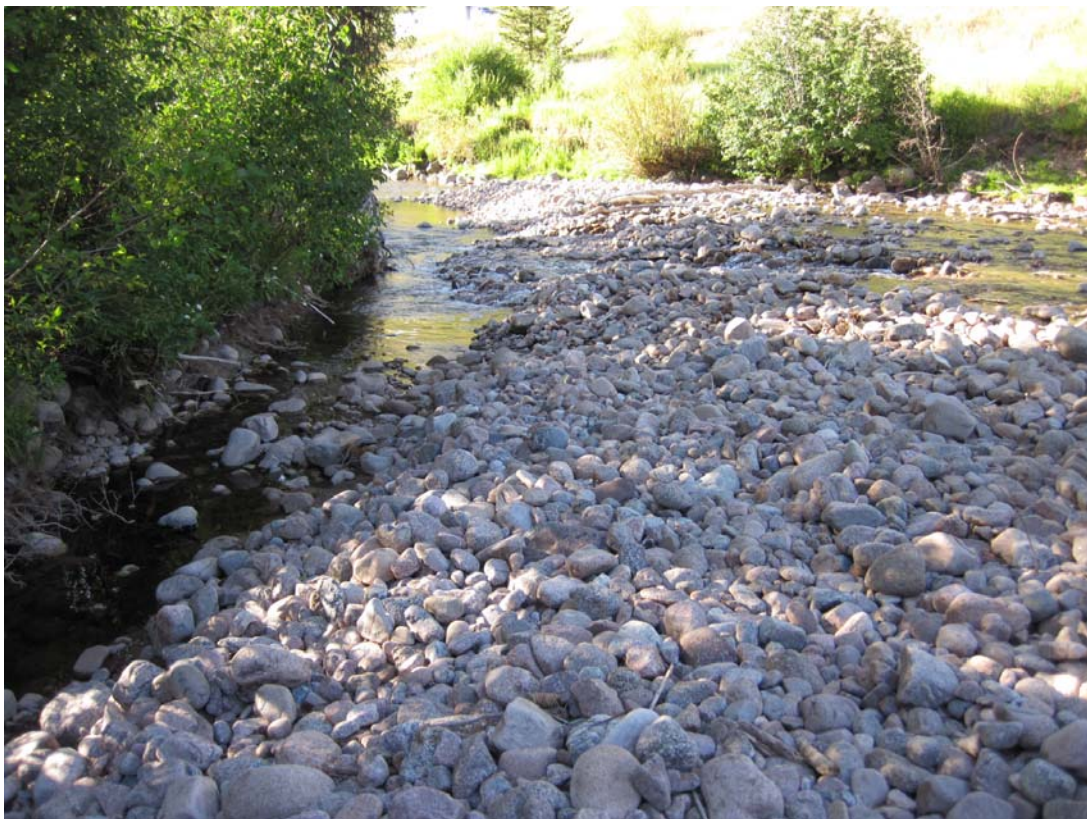
Figure 3. Typical channel aggradation in East Vail

Deposition in the main channel of Gore Creek has likely been exacerbated by adjacent landuse. The encroachments on the Bighorn Creek, Pitkin Creek and Booth Creek tributaries and development on the alluvial fans has prevented channel migration and deposition on those fans. Material may be more readily transported into Gore Creek that would otherwise deposit on the alluvial fans. Similarly, the land use encroachments of Gore Creek have reduced the main channel's ability to absorb new sediments by migrating and eventually aggrading the valley floor.

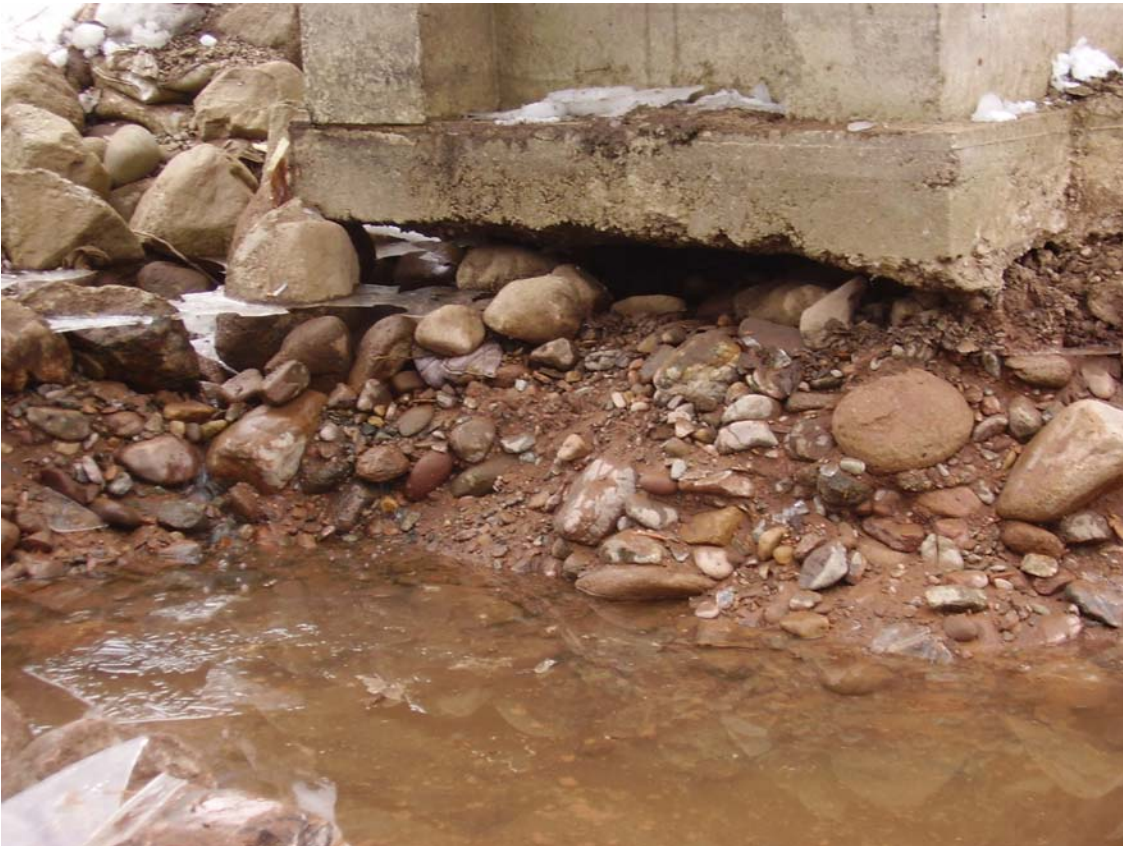
Damage from the 2010 flood event on Christopher Sewell Bridge was extensive. The south abutment was almost completely undermined and is supported by only a few small boulders without adequate subgrade. It is RiverRestoration's opinion that the abutment was not originally designed to adequate scour depth. The top of the abutment footer is at elevation 8516.5 feet and poured unevenly on native subgrade ground consisting of sand, gravel and cobble. The abutments may have been away from the main channel at the time of installation; however, the thalweg of the channel is now at the south abutment. Scour resulting from the 2010 flood went below elevation 8513.0 feet at the south abutment. The poorly consolidated subgrade material has eroded from under the entire abutment, extending up to six feet behind the face of the abutment.

South abutment Christopher Sewell Bridge inspected December 6, 2010, Vail, CO

After dewatered inspection, our recommended alternative is to rebuild the bridge and design new alignments, abutments, and spans to function with a mobile channel bed. However, we understand that Owners may seek a lower cost alternative, and furthermore, the perilous existing condition may result in collapse of the bridge after spring runoff 2011. Therefore, it is reasonable to attempt to stabilize the south abutment in place. We have provided a design to inhibit scour around the abutment, train the flow along the channel banks and resist the ongoing migration of the channel. In addition, concrete fill would be placed in the voids beneath the abutment. This alternative does not permanently rectify the fundamental design flaw of the original abutment and therefore should be considered a temporary fix. The longevity of the temporary fix is unknown and should be monitored. Detailed cost estimates and sketch plans are included in Appendix C. Cost Opinion: \$53,000.

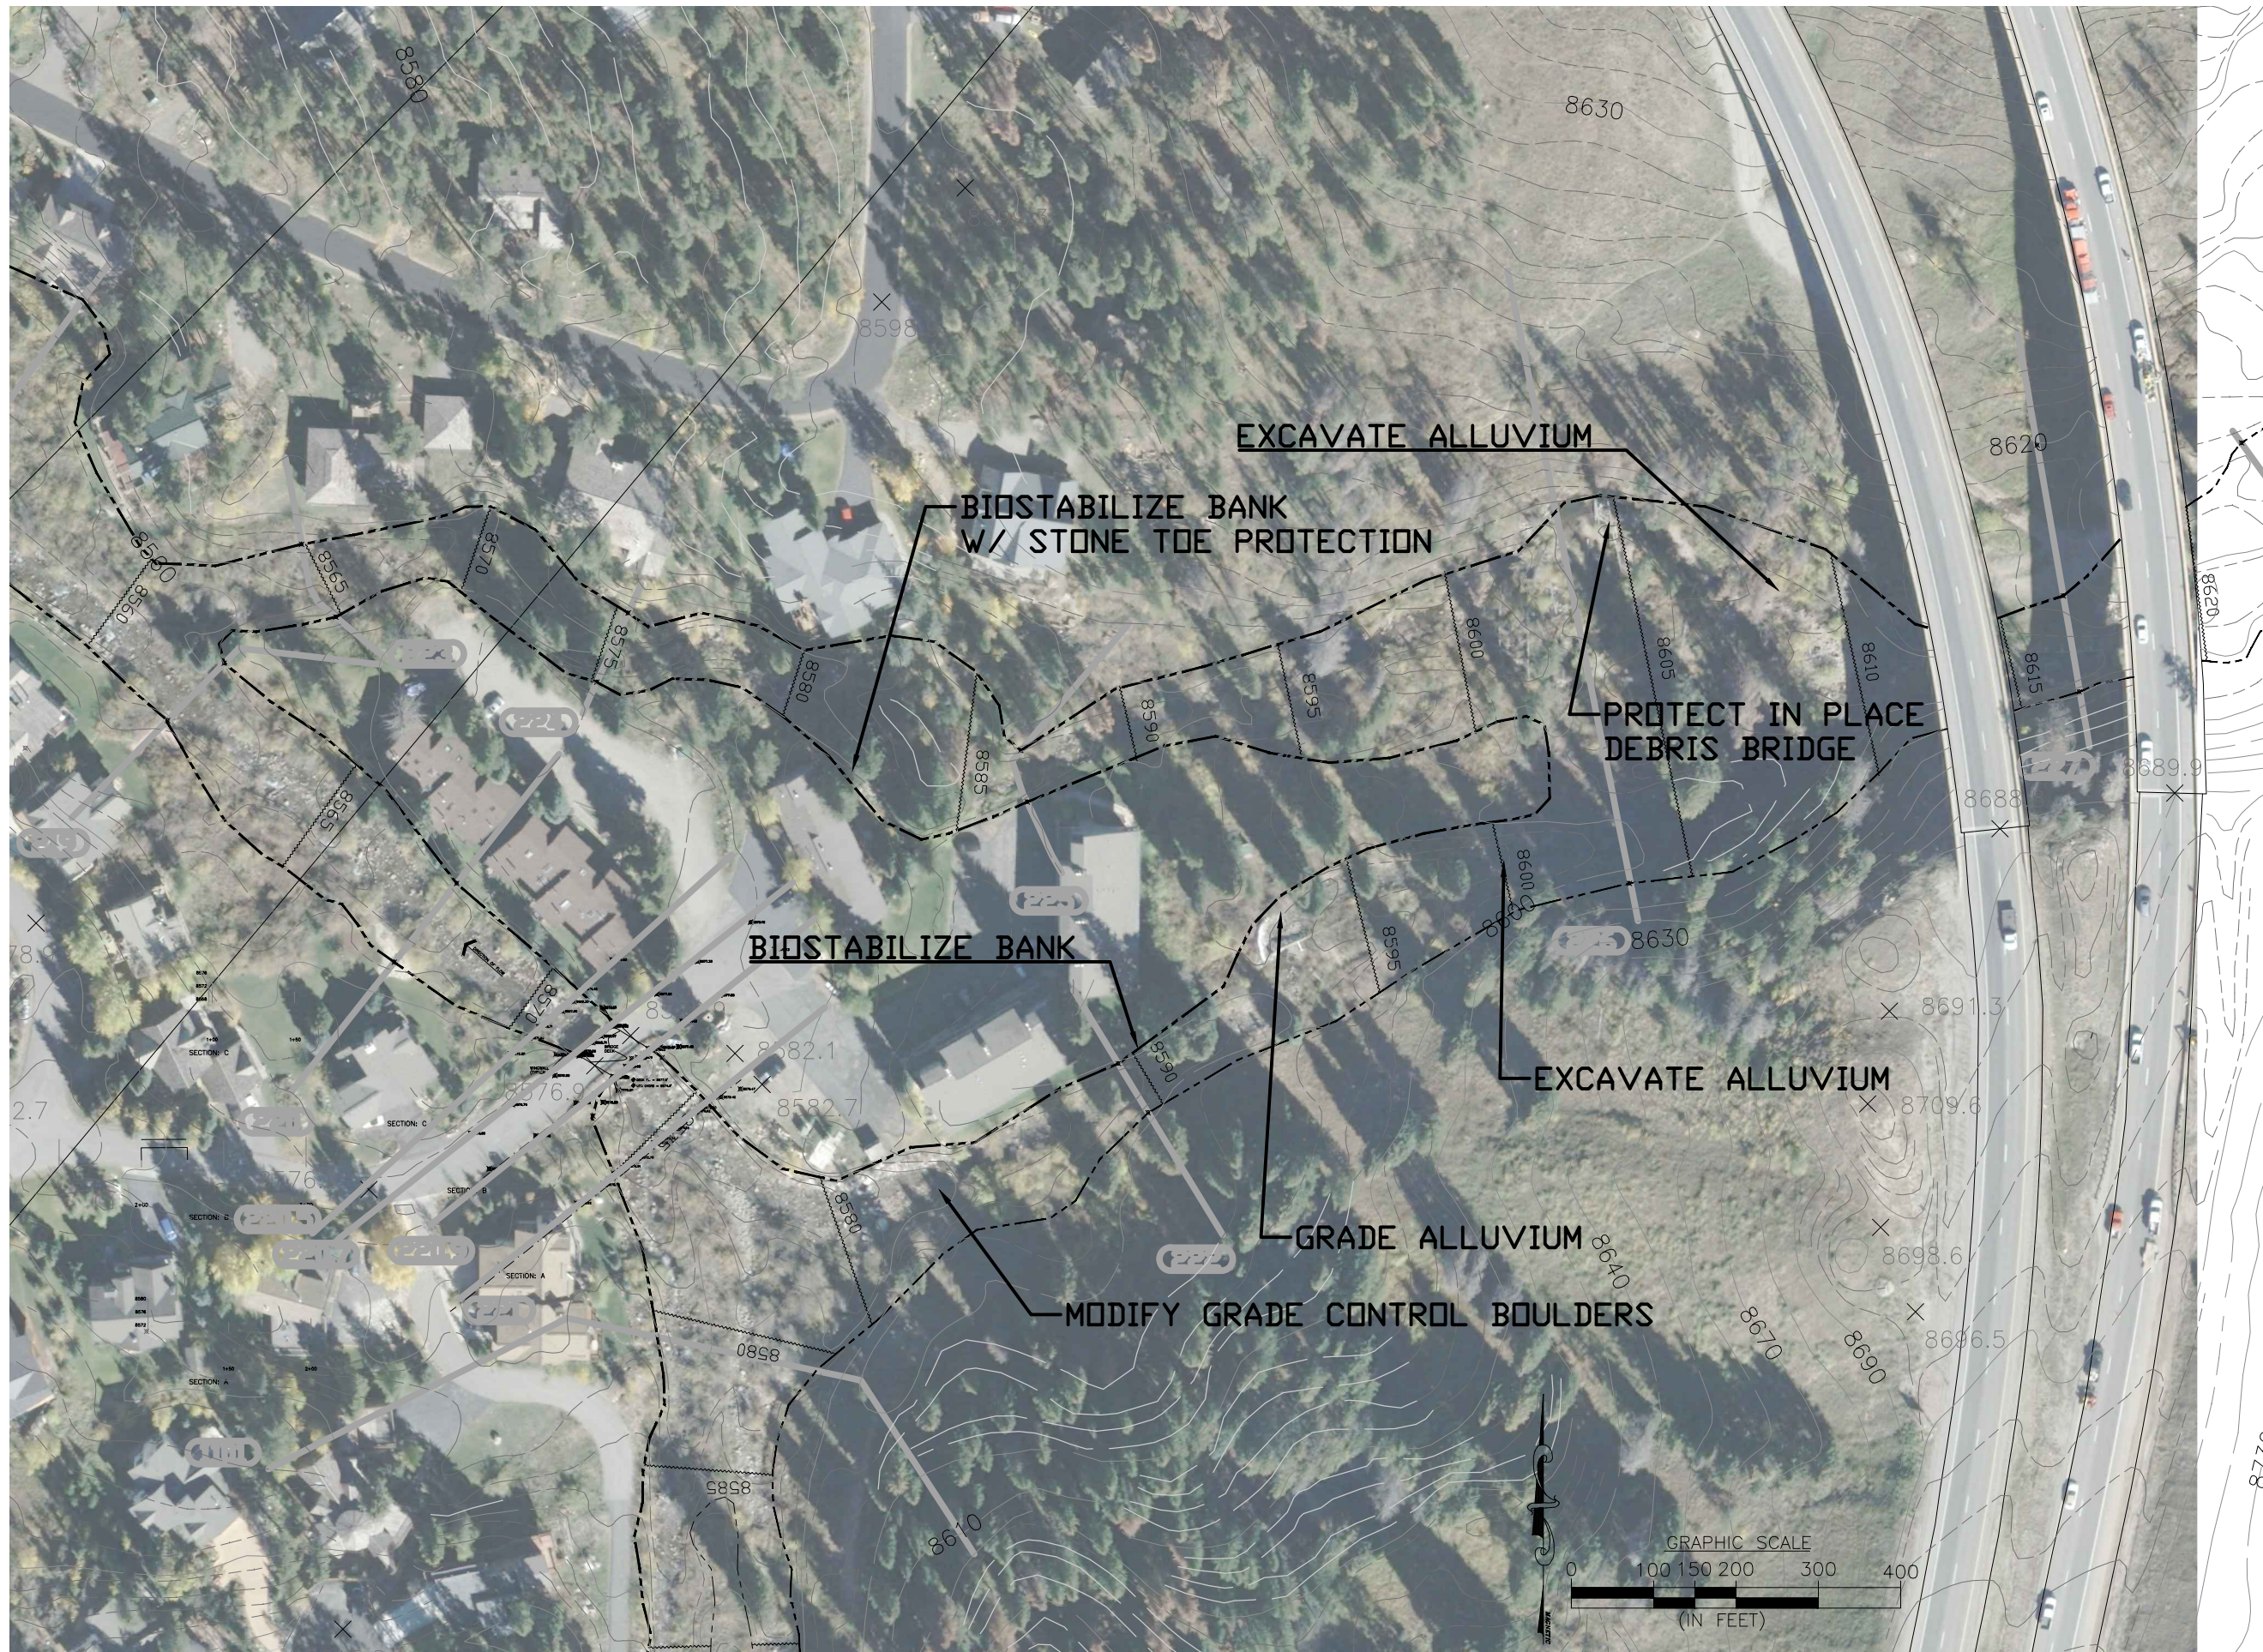
TOWN OF VAIL HEATHERS AT VAIL SKETCH DESIGN PLAN VIEW

Overall, the channels functioned ideally in 2010 to minimize flood damage to the structures. The debris bridge and sediment plug formation routed more water in the left (south) channel and prevented more significant damage that may have occurred without the increased left channel capacity. Both the right and left channels will likely have increased flood capacity after removal of the sediment plug.

- Remove Sediment Plug at head of Right (north) channel
- Excavate cobbles at left channel of left (south) channel island and place in right channel of island.
- Biostabilize right bank of left channel
- Reduce grade control at downstream end of left channel (check for utility crossing).
- Stabilize toe of right channel behind Heatherwood
- Mimic or replace debris bridge for plug re-formation during future flood events.
- Cost Opinion: \$47,000

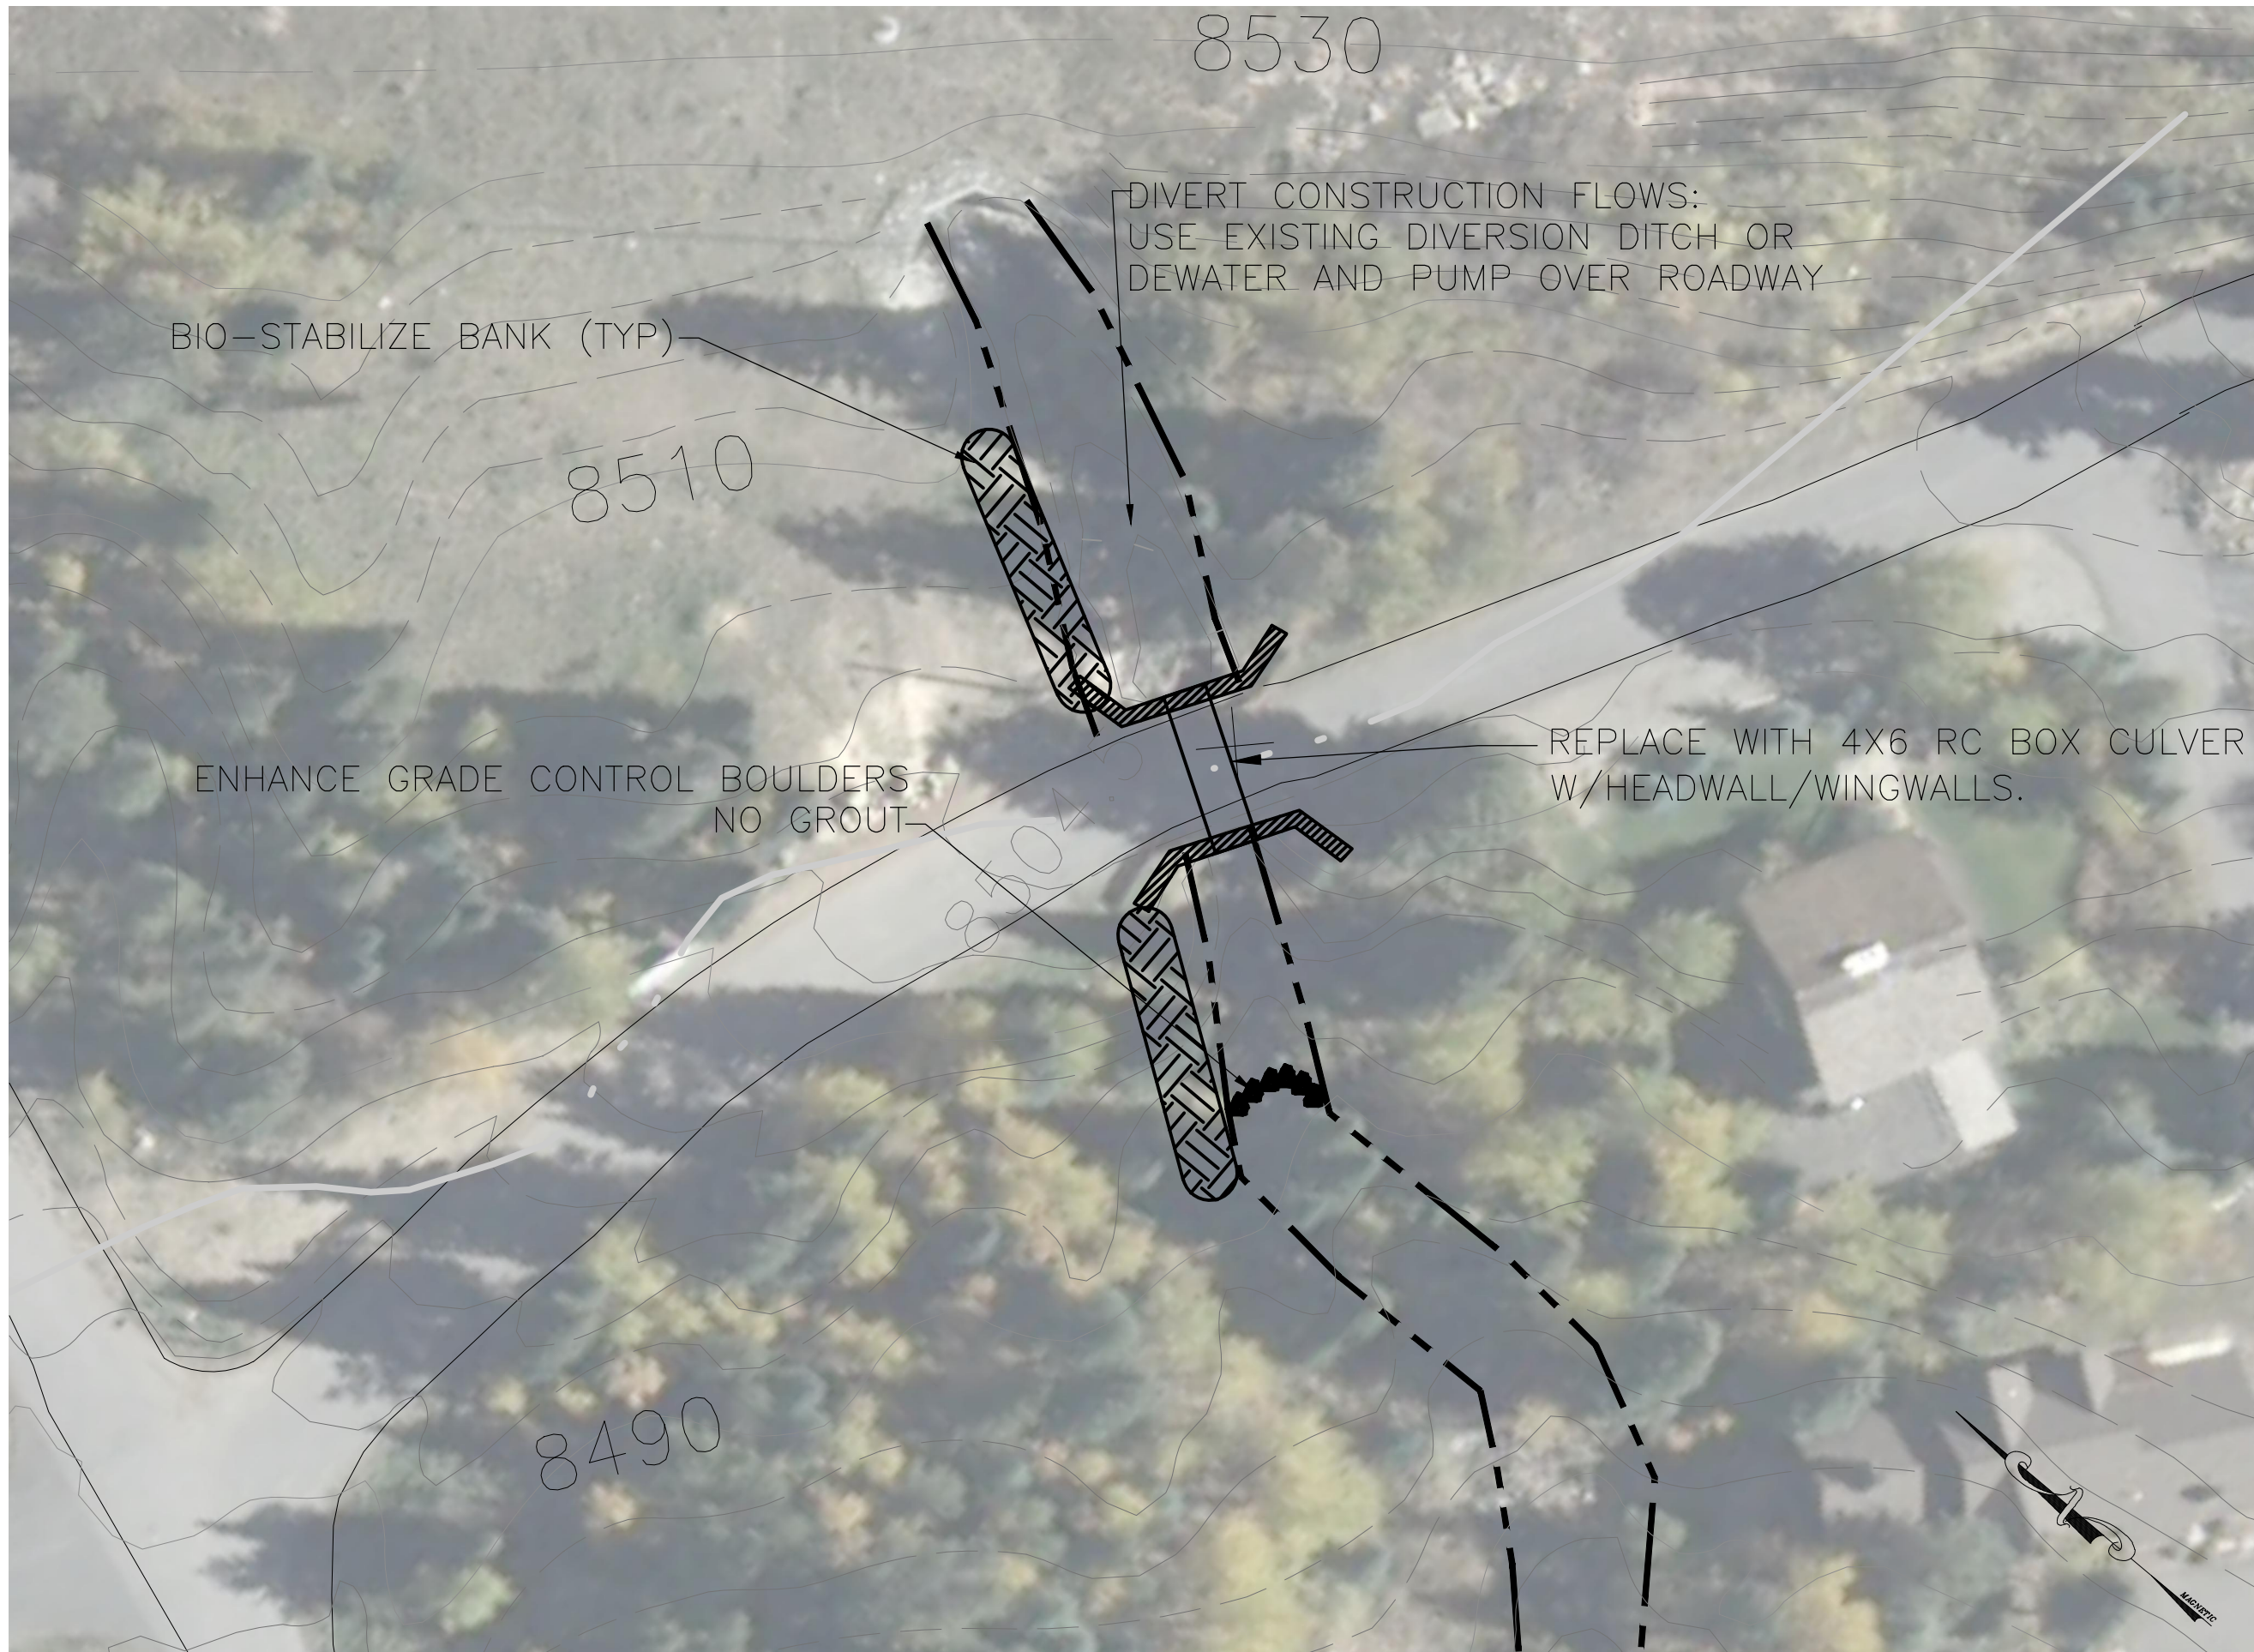
TOWN OF VAIL
 BIGHORN CK/SPRUCE WAY CULVERT
 SKETCH DESIGN
 PLAN VIEW

The Spruce Way metal culvert has not been significantly ripped; however significant erosion at the head and the outlet has caused pooling of water around the culvert ends. This pooling may eventually lead to ground water infiltration and piping around the culvert and collapse similar to the 2003 I-70 culvert. Similar to Columbine Way, a natural boulder grade control pools water at the outlet and helps reduce the groundwater gradient across the culvert. The solution to limiting ground water outside of the culvert at Spruce Way is to install head walls; however, the culvert floor should also be bedded with 6 inches of concrete to prevent the eventual ripping of the culvert, and to ensure culvert longevity similar to the expected life of the head walls.

Headwalls at Spruce Way are an immediate solution, but in our opinion not a long term solution to the broader problems in Bighorn Creek. Furthermore, installation of headwalls on the existing pipe will likely require road closure and repair. It is our opinion that the cost and complications of in-situ head walls, coupled with in-situ concrete flooring of the culvert, will be similar to costs for completely replacing the culvert, wherein a superior product may be achieved.

- 2) Temporary stabilize grade control outlet at Spruce Way with rock and grout: \$8,000
- 3) Replace culvert at Spruce Way with a concrete box structure (4' x 6') with concrete wing/head walls and permanent grade control: \$129,000
- 4) Replace culvert at Columbine Way with a concrete box structure (4' x 6') with boulder wing walls and permanent grade control: \$104,000

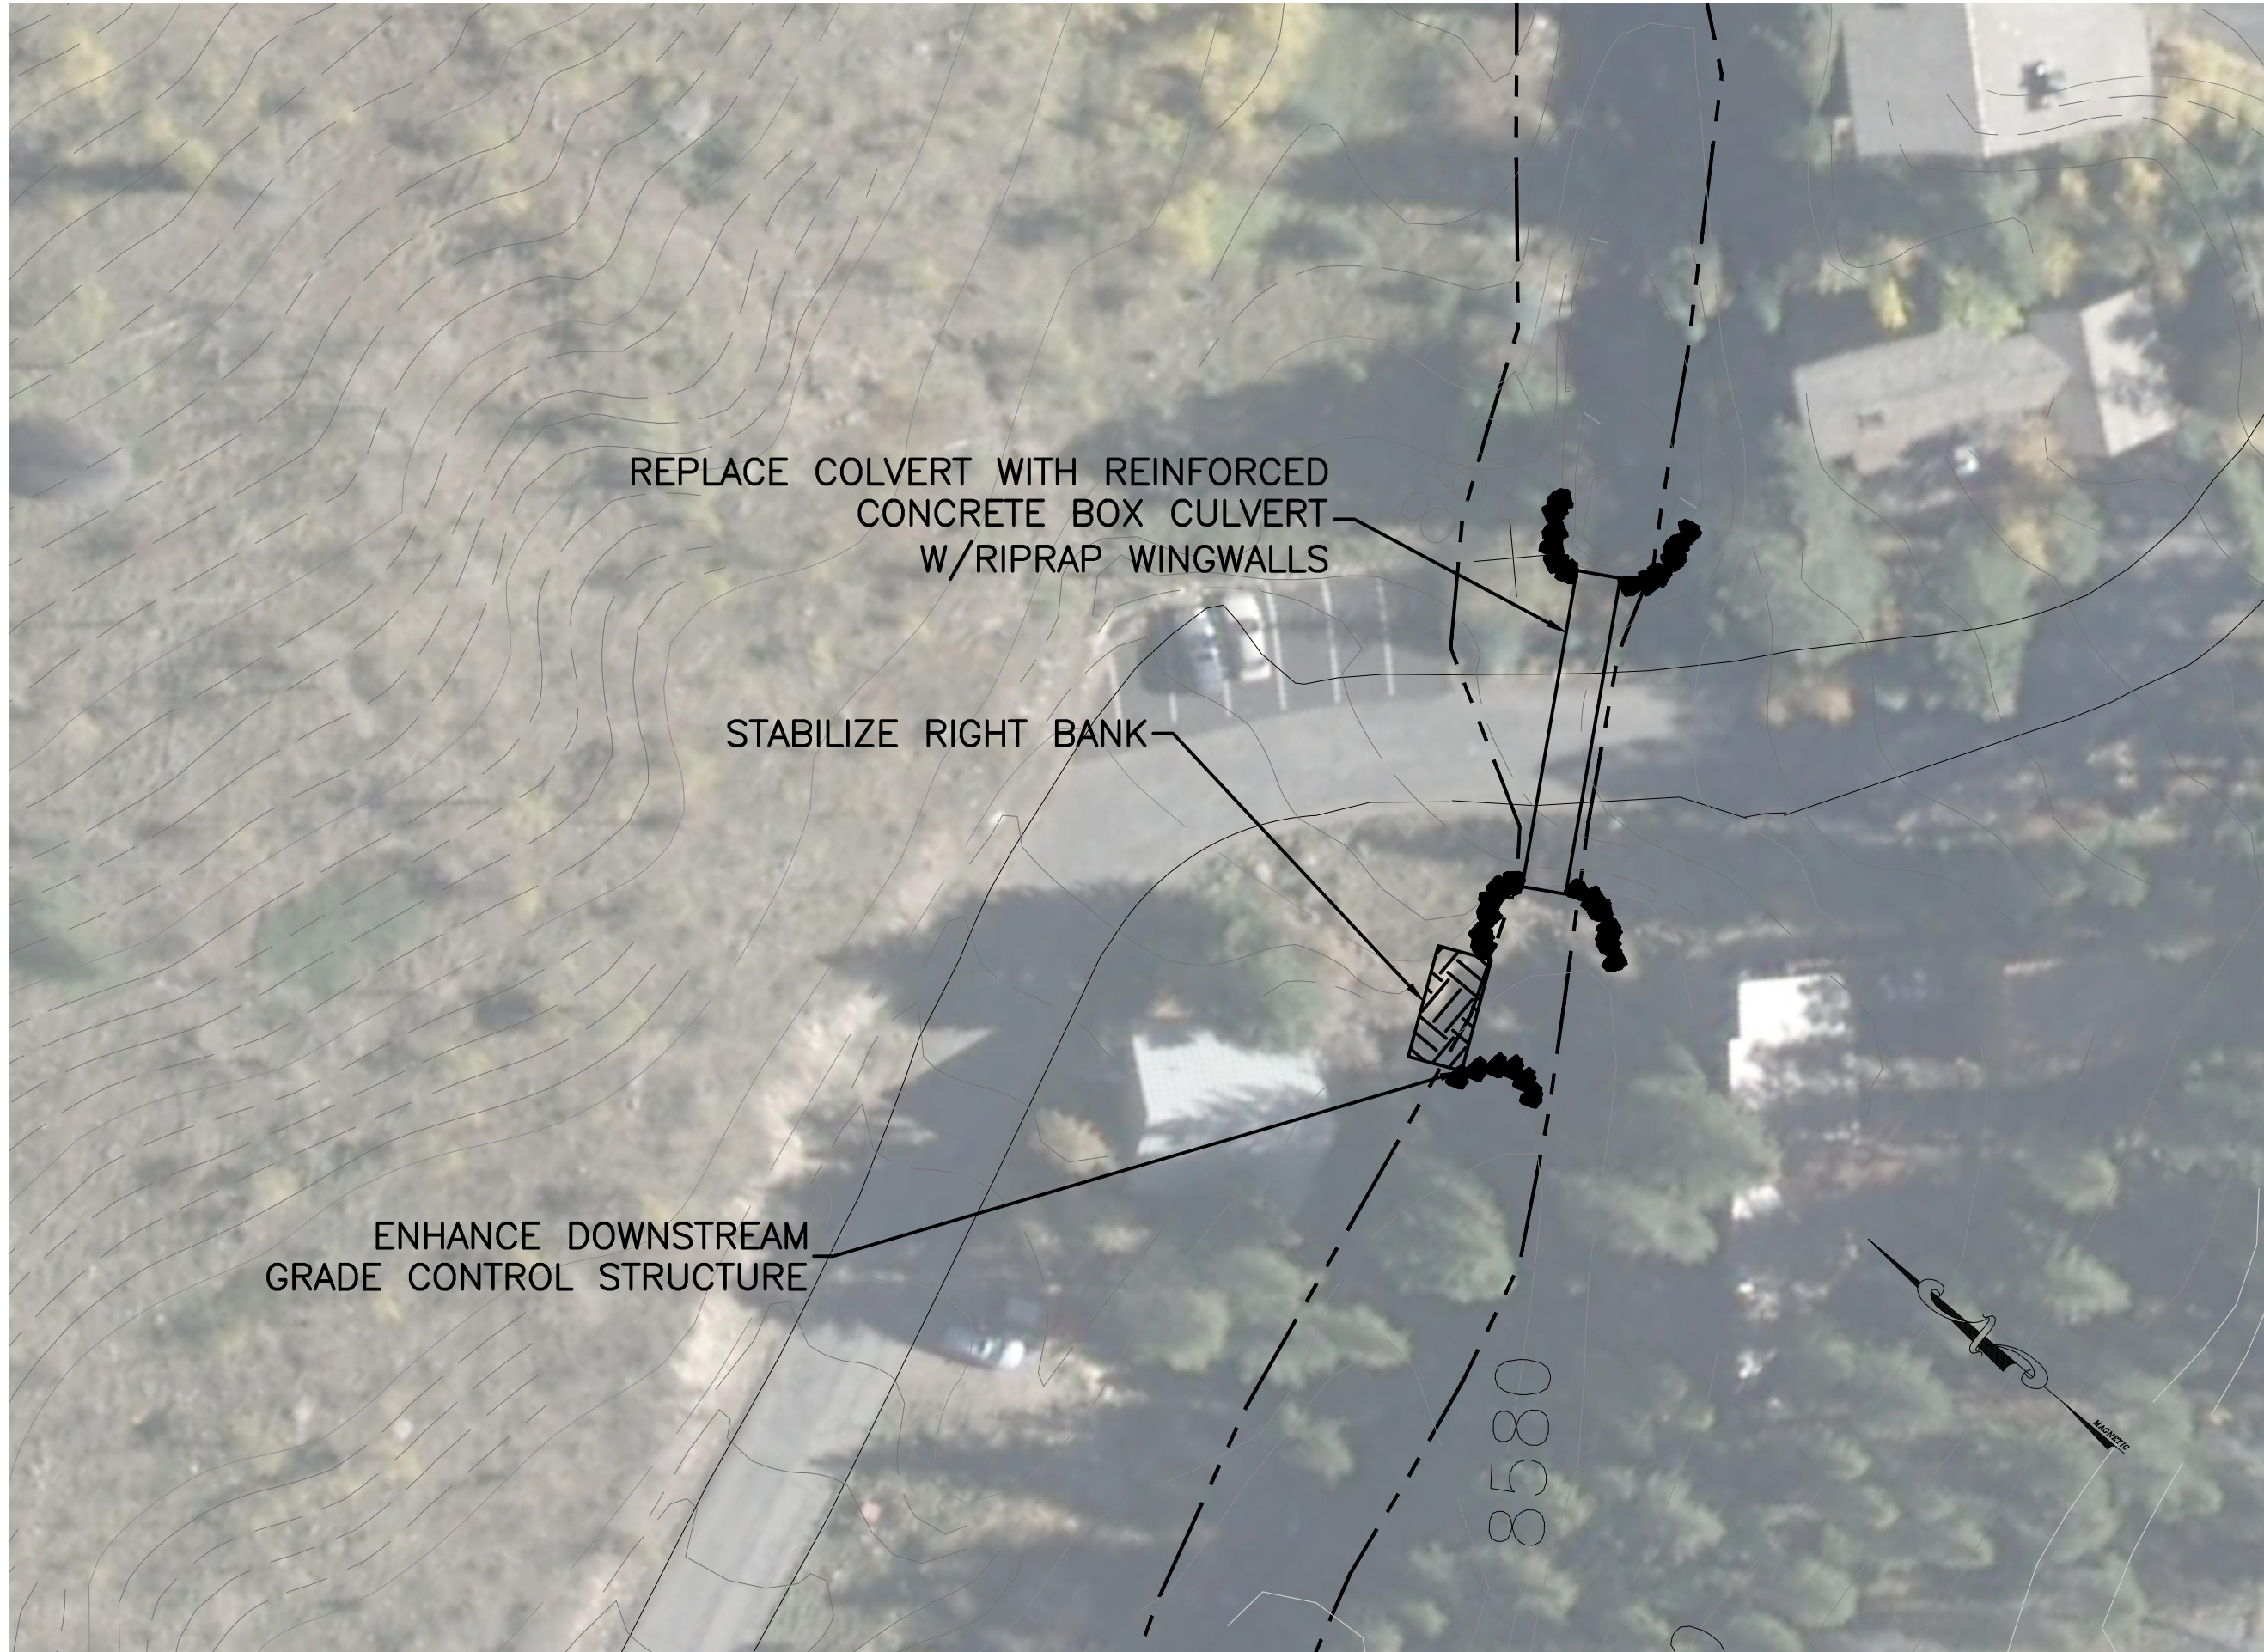
TOWN OF VAIL
 BIGHORN CK. AT COLUMBINE DR.
 SKETCH DESIGN
 PLAN VIEW

The Columbine Way culvert has been highly compromised by rock transporting through. The rips in the culvert are likely creating paths for groundwater to pipe and infiltrate beneath the culvert. The channel cutting downstream of the culvert outlet has destabilized the channel; however, a natural grade control of boulders remains downstream of the outlet which helps keep a pool at the outlet and reduces the groundwater gradient across the culvert. This grade control is very unstable and loss of the grade control (simply by a boulder shifting) may significantly increase the hydraulic gradient of ground water across the Columbine Way culvert, increasing infiltration and piping and may eventually compromise the integrity of the road.

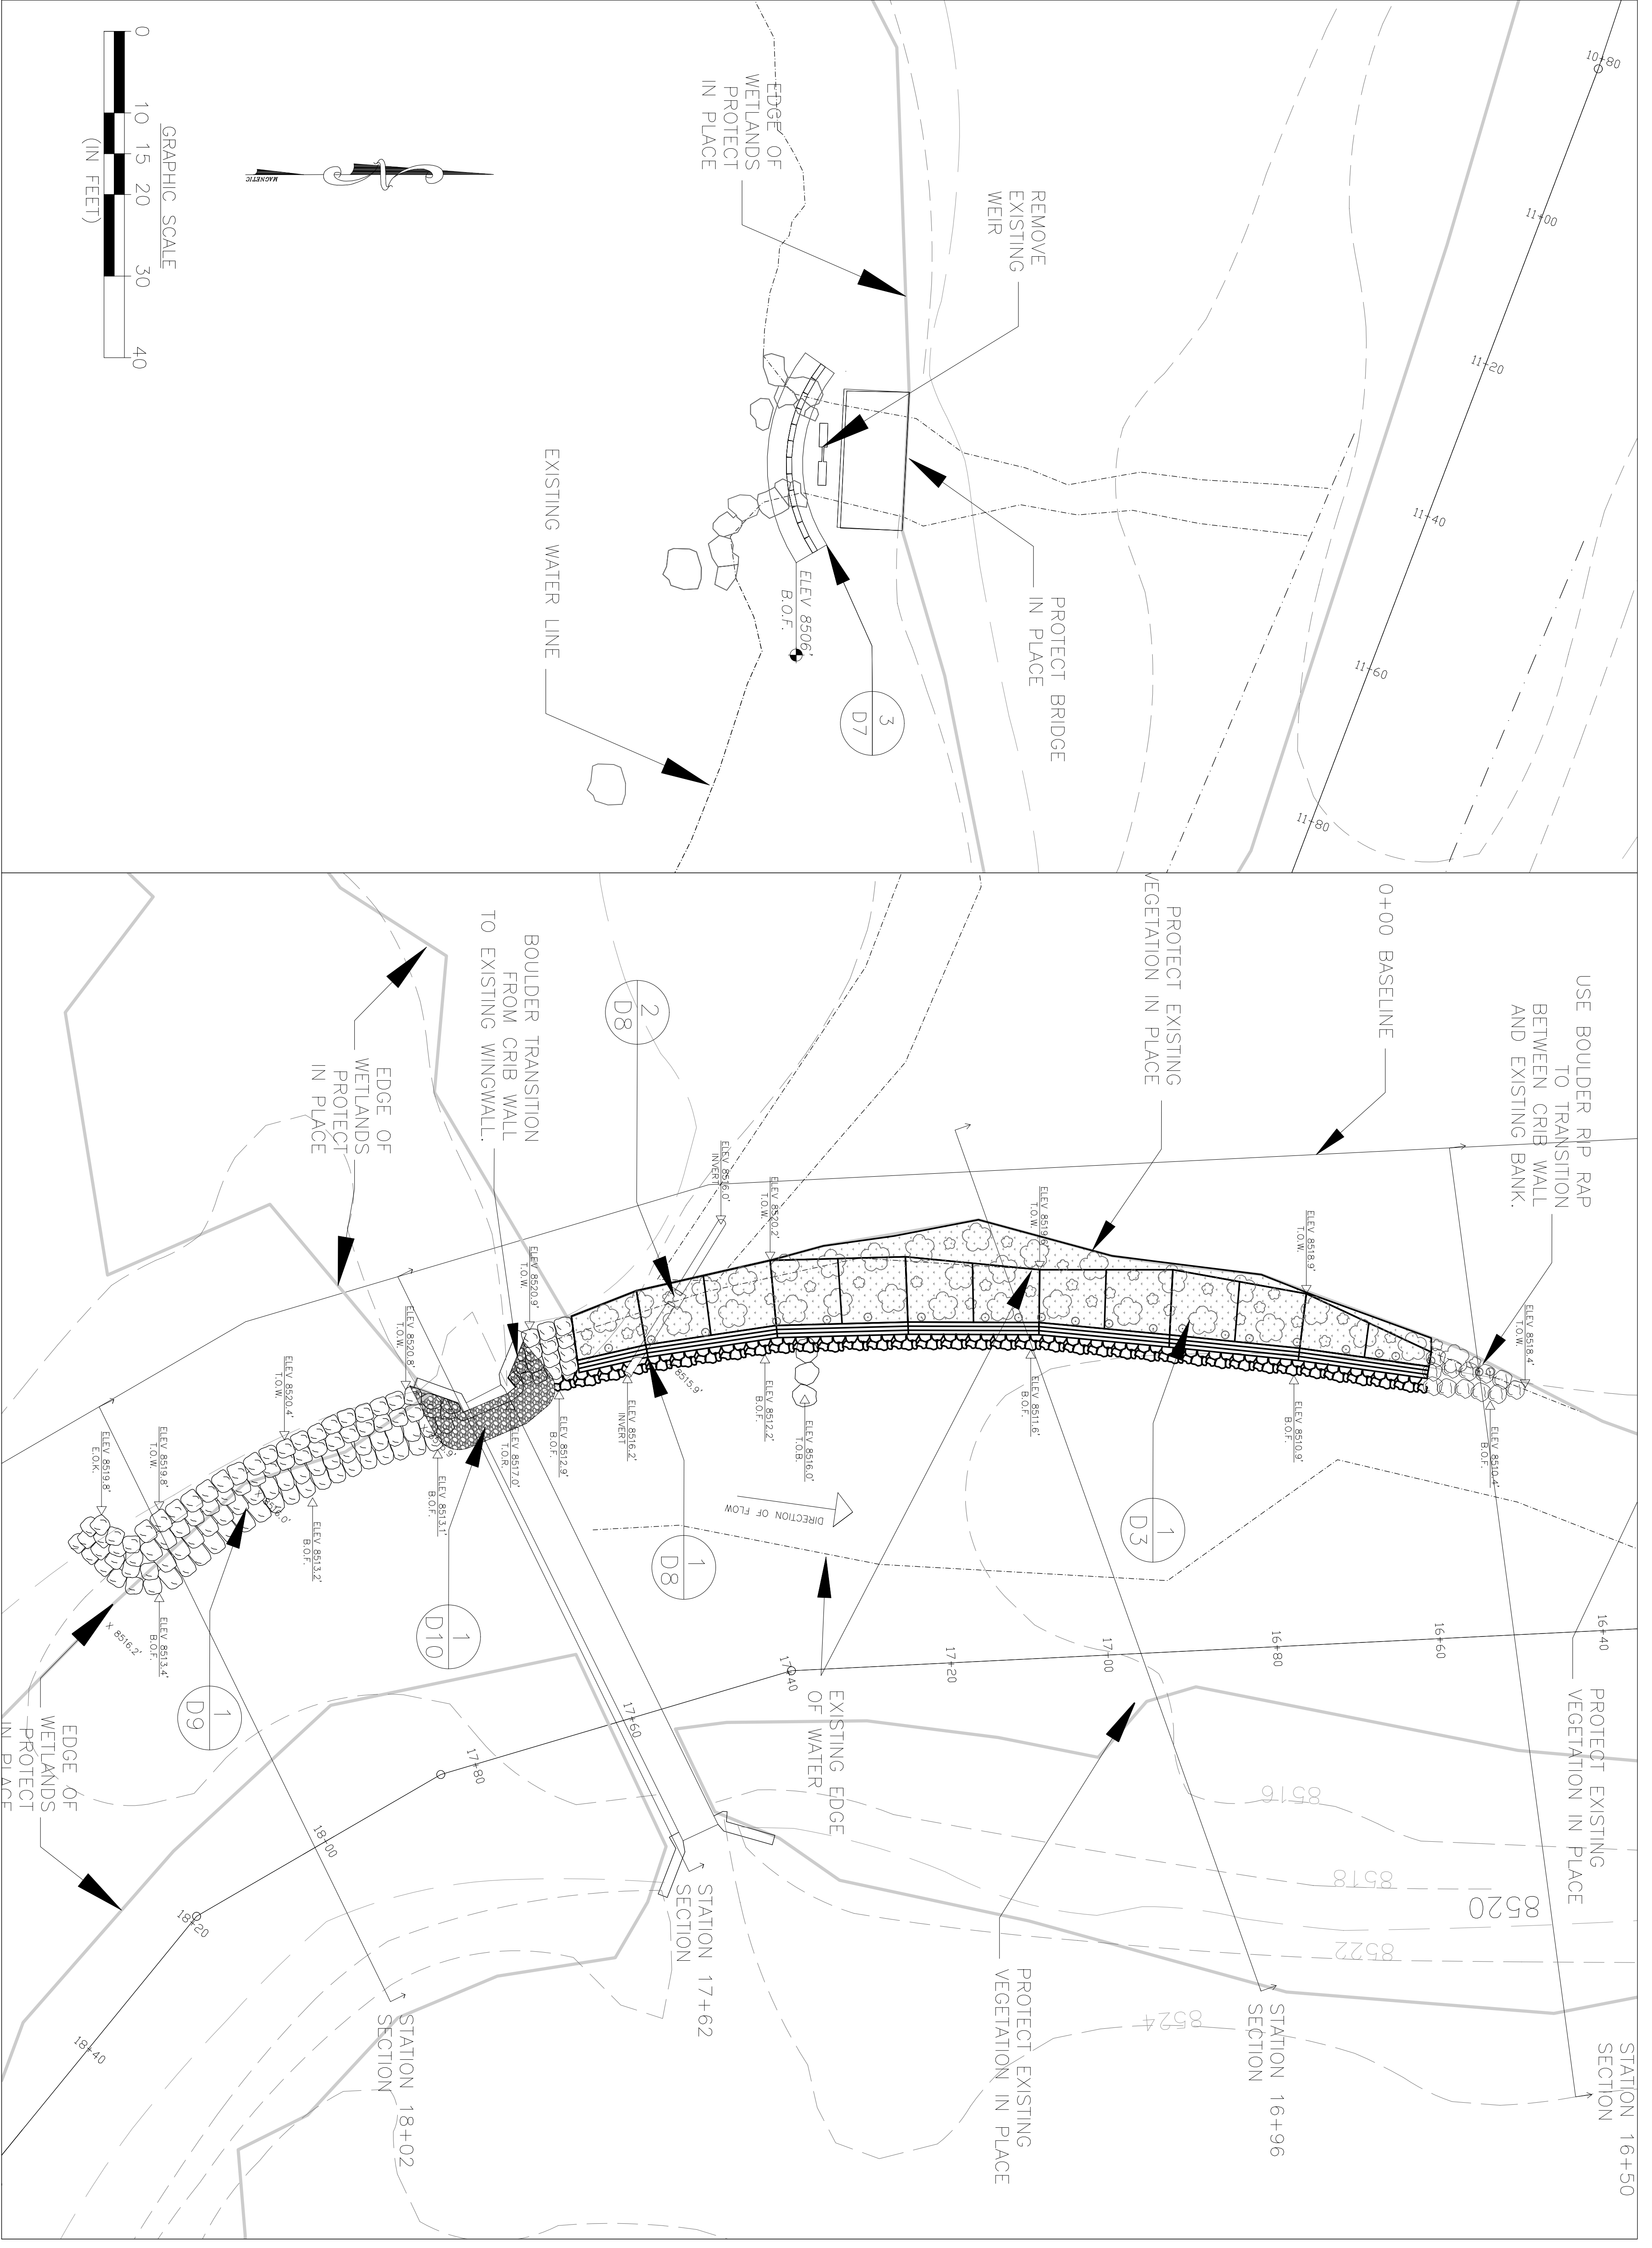
TOWN OF VAIL BIGHORN POND STABILIZATION FINAL DESIGN PLAN VIEW

The design rationale for the bank stabilization, inlet repair, and low flow spillway replacement at Bighorn Pond (pond) is intended to protect the pond from capture during future flood events less than a 100-year event. Construction of approximately 120 feet of crib walls along the south bank downstream of the Christopher Sewell Bridge (pedestrian bridge) restores the bank line prior to the flooding events of 2010 while increasing the bank elevation to reduce future over-bank flooding. Construction of approximately 50 feet of boulder retaining wall upstream of the pedestrian bridge would restore the bank line to a pre-2009 position and reduce the advancing channel migration. Replacing the existing spillway weir is designed to improve outflow capacity of the pond to be sized with inlet capacity.

The existing inlet culvert immediately downstream of the pedestrian bridge, which was damaged during the 2010 flood, will be replaced. The inlet culvert configuration dimensions and elevations will not be modified, other than the addition of a gate. The gate will allow for some inlet control during flood events and maintenance periods.

Re-sizing of the low flow spillway has been performed to offer increased conveyance capacity during high stream flow events while maintaining the existing low flow pond surface elevations. The current capacity of the existing weir coupled with the vertical standpipe is insufficient (less than 5 cfs) to convey the combined stream flow obtained from the two inlet culverts (approximately 10 cfs) at Bighorn Pond. Furthermore, the existing weir was compromised during flooding in 2010 and has significant leakage around its end. A compound radial spillway was designed for increased conveyance, groundwater cutoff, and improved aesthetics.
