Vail 2010 Flood Assessment

January 27, 2011

Prepared For:
Town of Vail
Department of Public Works
1309 Elkhorn Drive
Vail, CO 81632

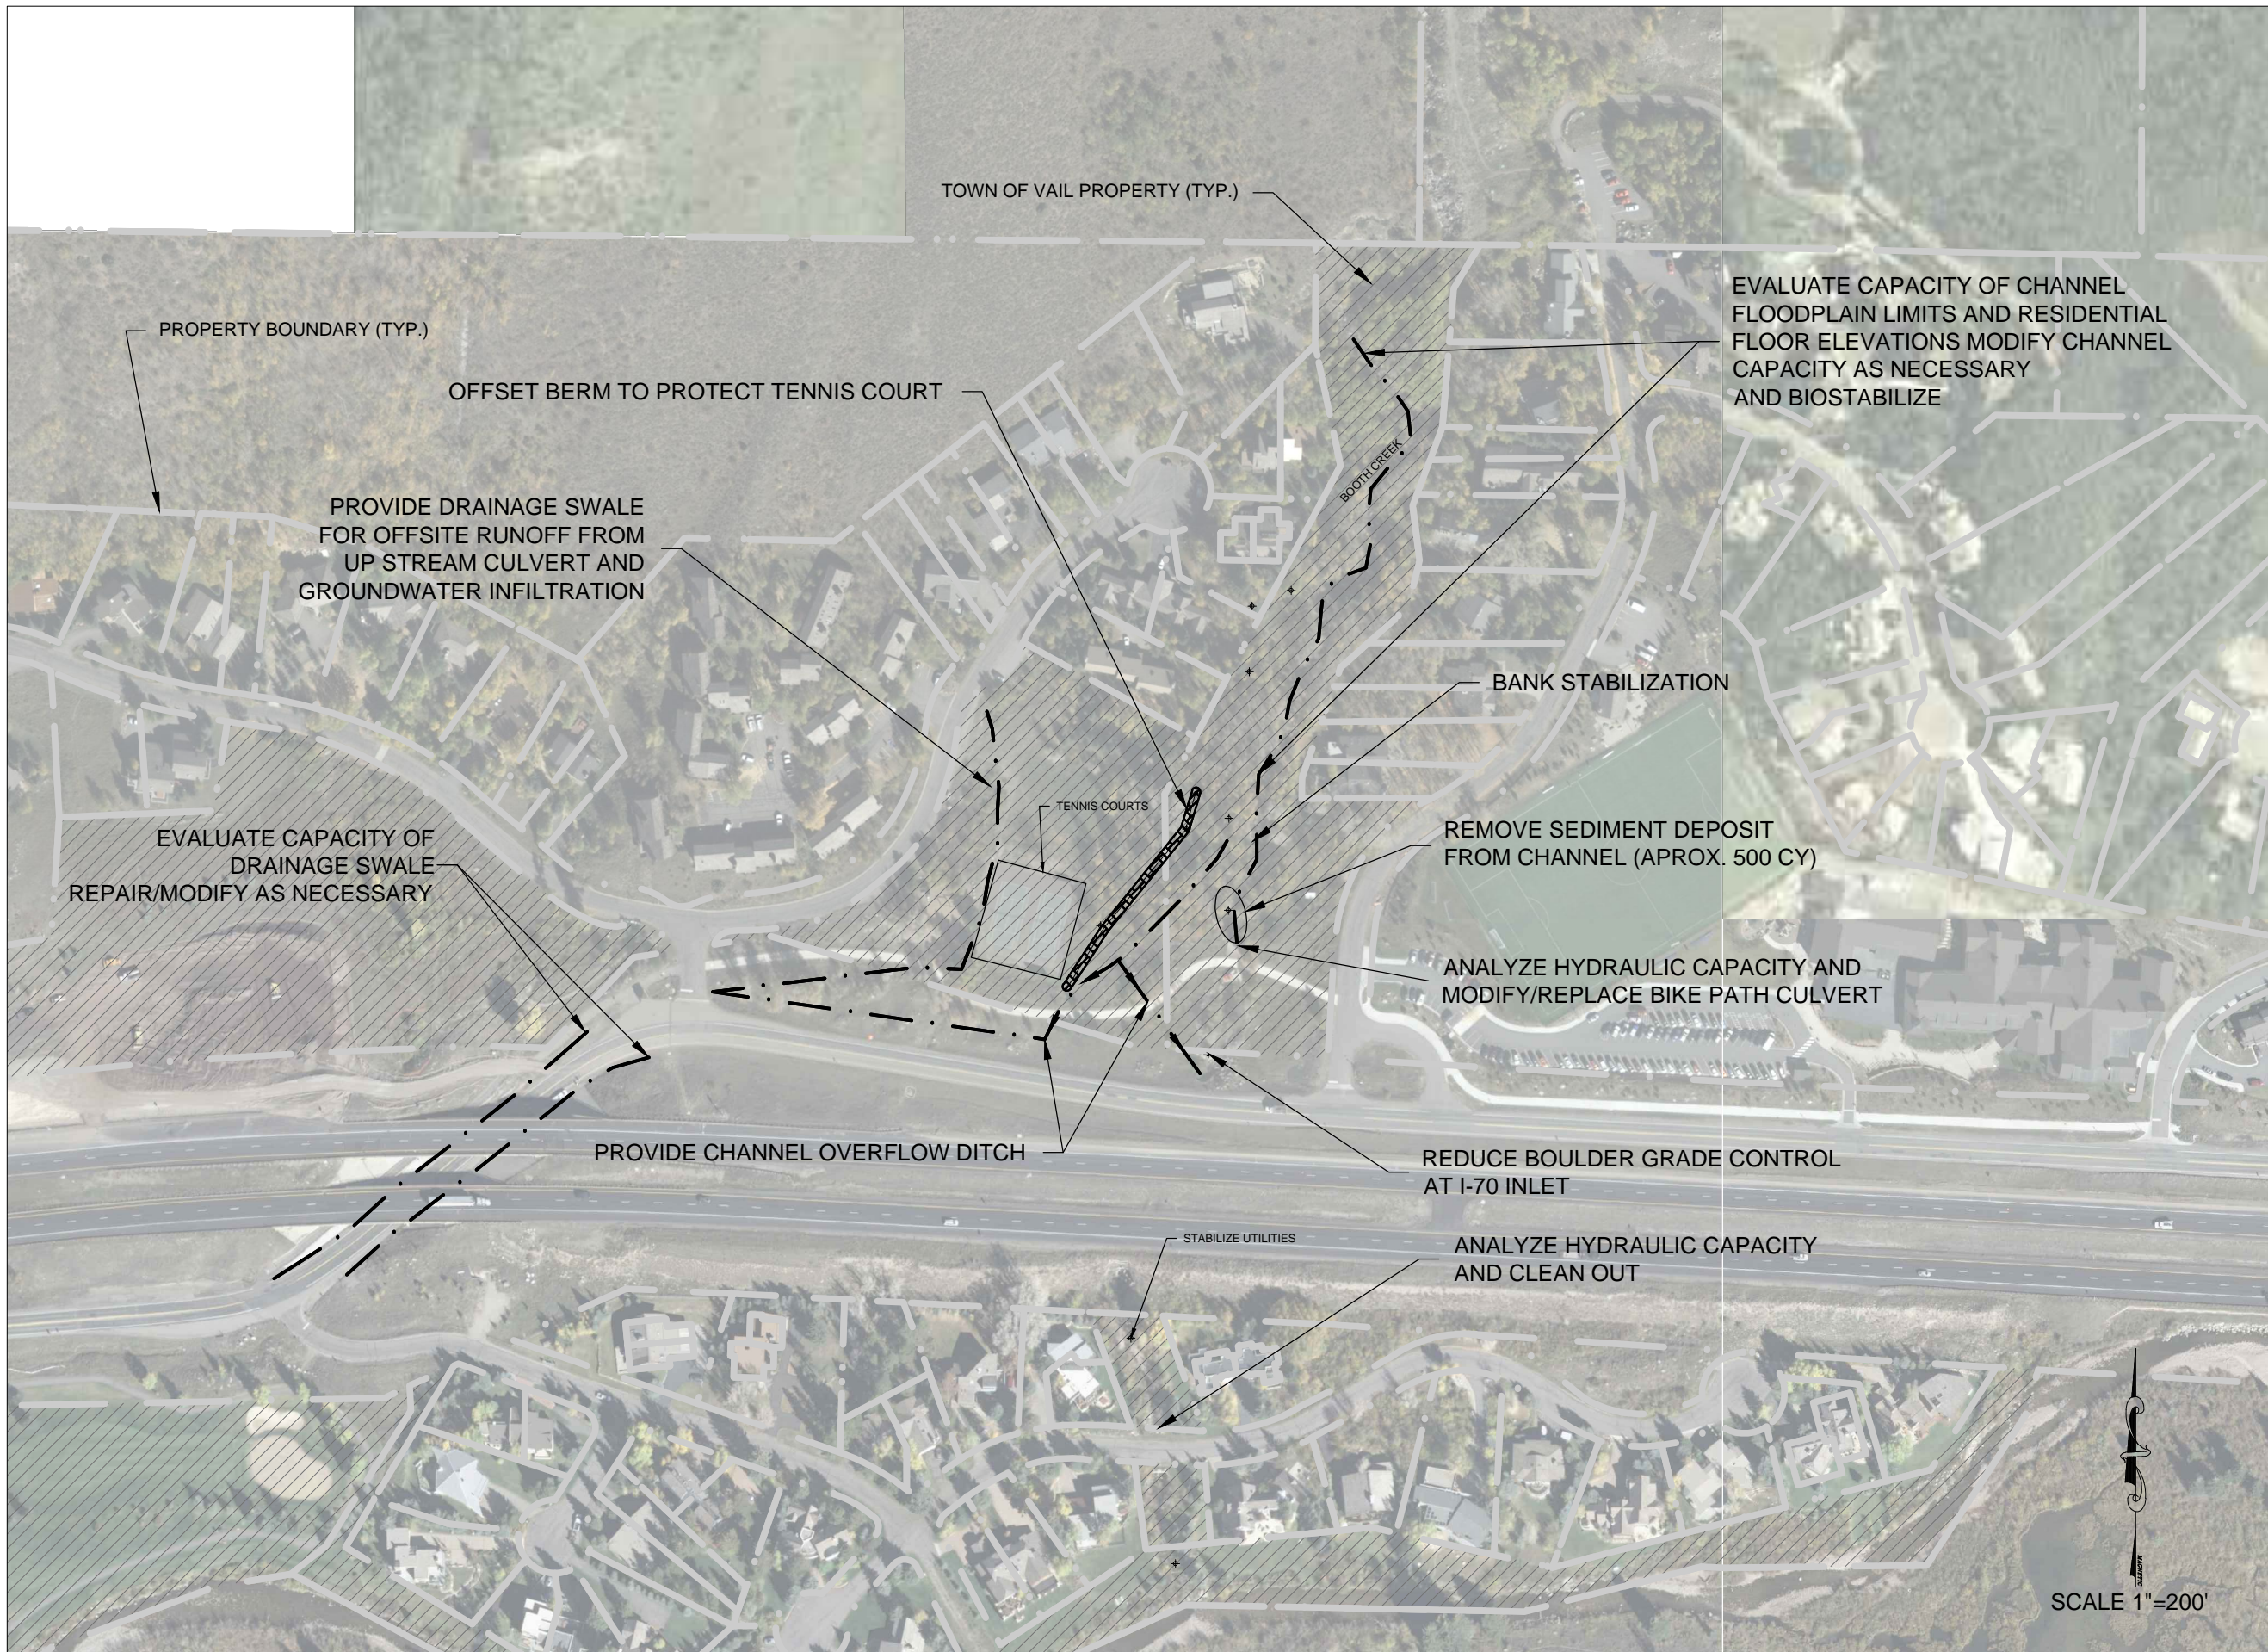
**TOWN OF VAIL
 BOOTH CREEK RESTORATION
 CONCEPTUAL PLAN
 PLAN VIEW**

During this most recent event, significant channel widening and down cutting and associated erosion and periodic deposition occurred in Booth Creek. Significant loss of land occurred most significantly in areas where the riparian zone was thinned and replaced with grasses. Significant overbank flooding and deposits and other damage were sustained at the tennis courts, in the playground, on the bike path culvert and along the frontage road.

Booth Creek flows through a large, moderate gradient, alluvial fan with intermittently perched channel. Overbank flooding occurred throughout the channel but flows mostly returned to the main channel. Approximately 200 feet upstream of the bike path culvert (originally installed for U.S. Highway 6), overbank flooding did not return to the main channel and damaged the tennis courts and frontage road with deposits and erosion. Ground water upwelling or offsite flows are suspect for flooding west of tennis courts and damage to the playground area.

Detailed costs and sketch plans are included in Appendix C. Recommended measures include:

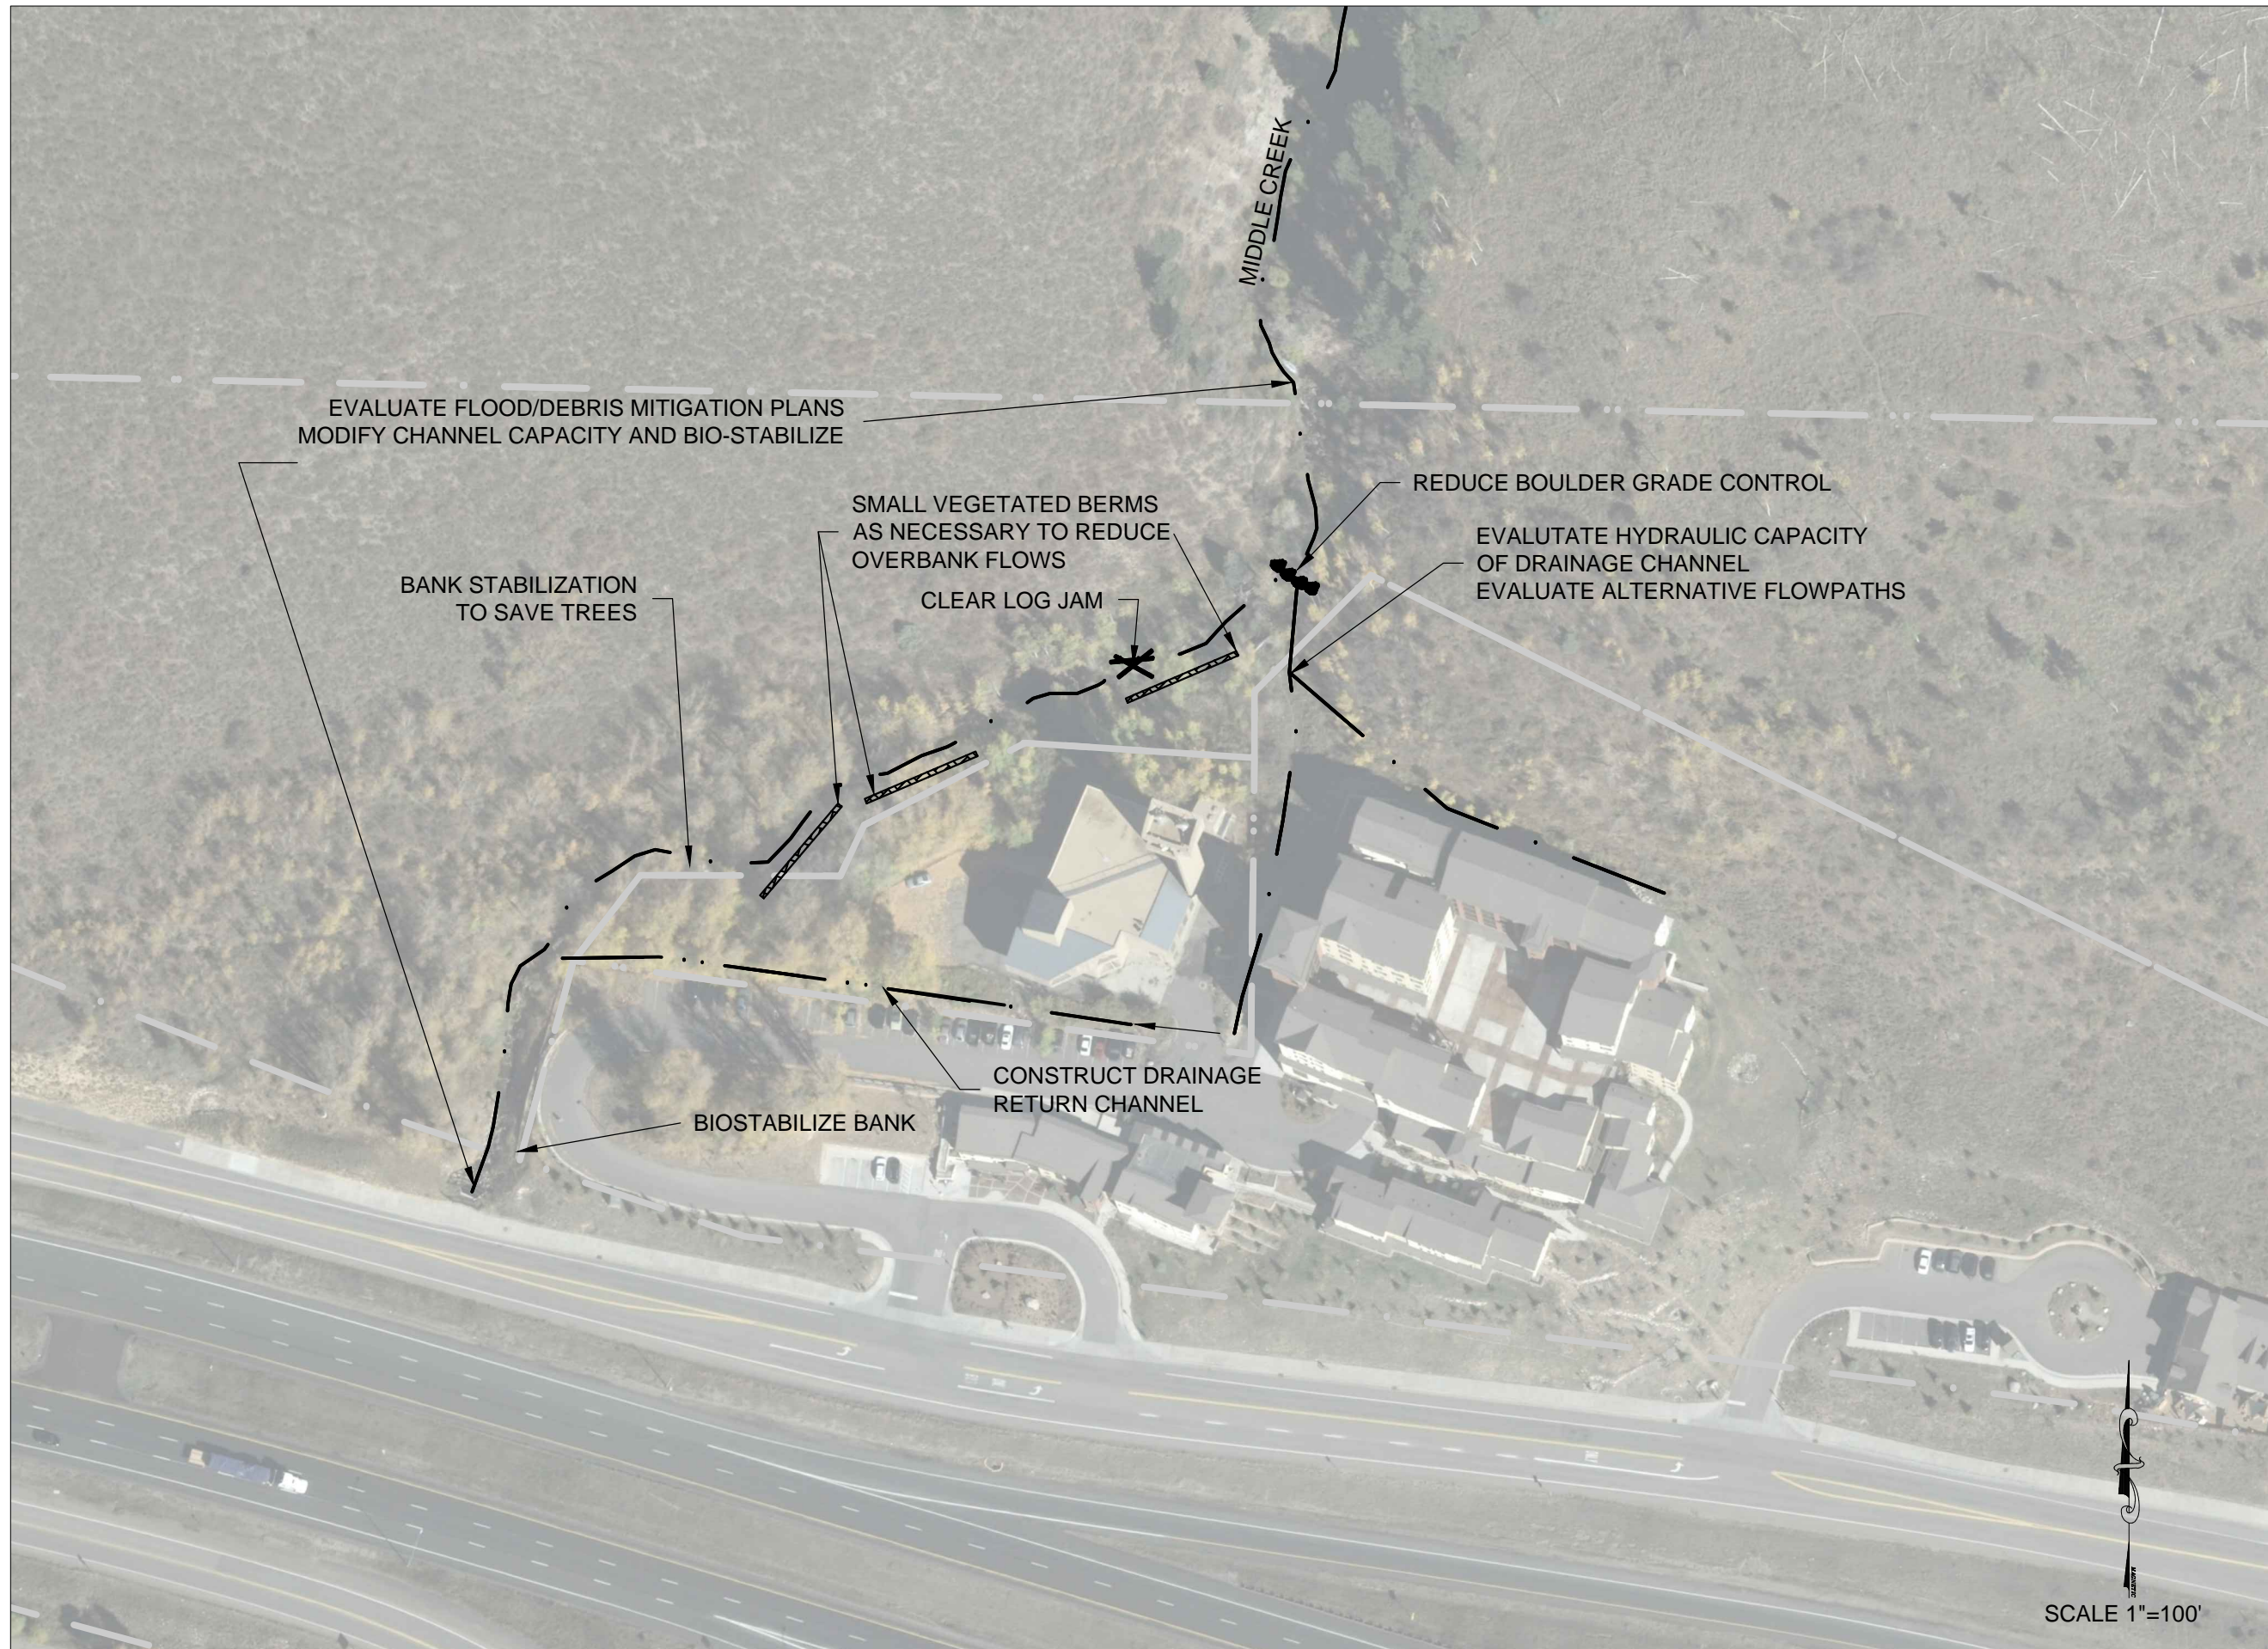
TOWN OF VAIL
MIDDLE CREEK RESTORATION
CONCEPTUAL PLAN
PLAN VIEW

Middle Creek experienced overbank flooding and isolated bank erosion in June of 2010. Middle Creek flows in the longest possible planform as it traverses a very steep alluvial fan. The channel is perched and overbank channels have numerous high gradient overbank paths. Debris jams could lead to avulsion which is exacerbated by the perched condition. The Bell Tower was apparently constructed with designed drainage, flood and mud and debris mitigation and controls; however, Building "C" of the condos appears to block or modify one of the Bell Tower mitigation drainages and does not appear to have designed flood mitigation specific to the condos. It is also suspect that Middle Creek was realigned to its current perched position during construction of the Bell Tower. Erosion of the road fill slope at the switchback did not appear significant; the boulder toe appeared to be in place. However this area should be bio-stabilized. Additionally, erosion should be monitored and the as-built designs of the retaining walls should be evaluated for designed scour depth.

Similar to Booth Creek the mitigation plans outlined for Middle Creek are designed to handle a flood event similar to 2010. The mapped 100-year floodplain for Middle Creek may not represent the actual flood hazard in this area. This mapping should be reviewed by the floodplain administrator and any necessary adjustments to floodplain management should be made. Additionally the Town should review the flood and debris flow mitigation plans for the properties located on the alluvial fan to ensure that the development of these properties meets land use code. This process may identify other changes that need to be made such as modifying the land use code to restrict development on active alluvial fans. Once these reviews are made the Town and adjacent property owners must weigh the costs of implementing the mitigation design versus the cost of cleanup and repair after a large event.

Detailed costs and sketch plans are presented in Appendix C. Recommended measures include:

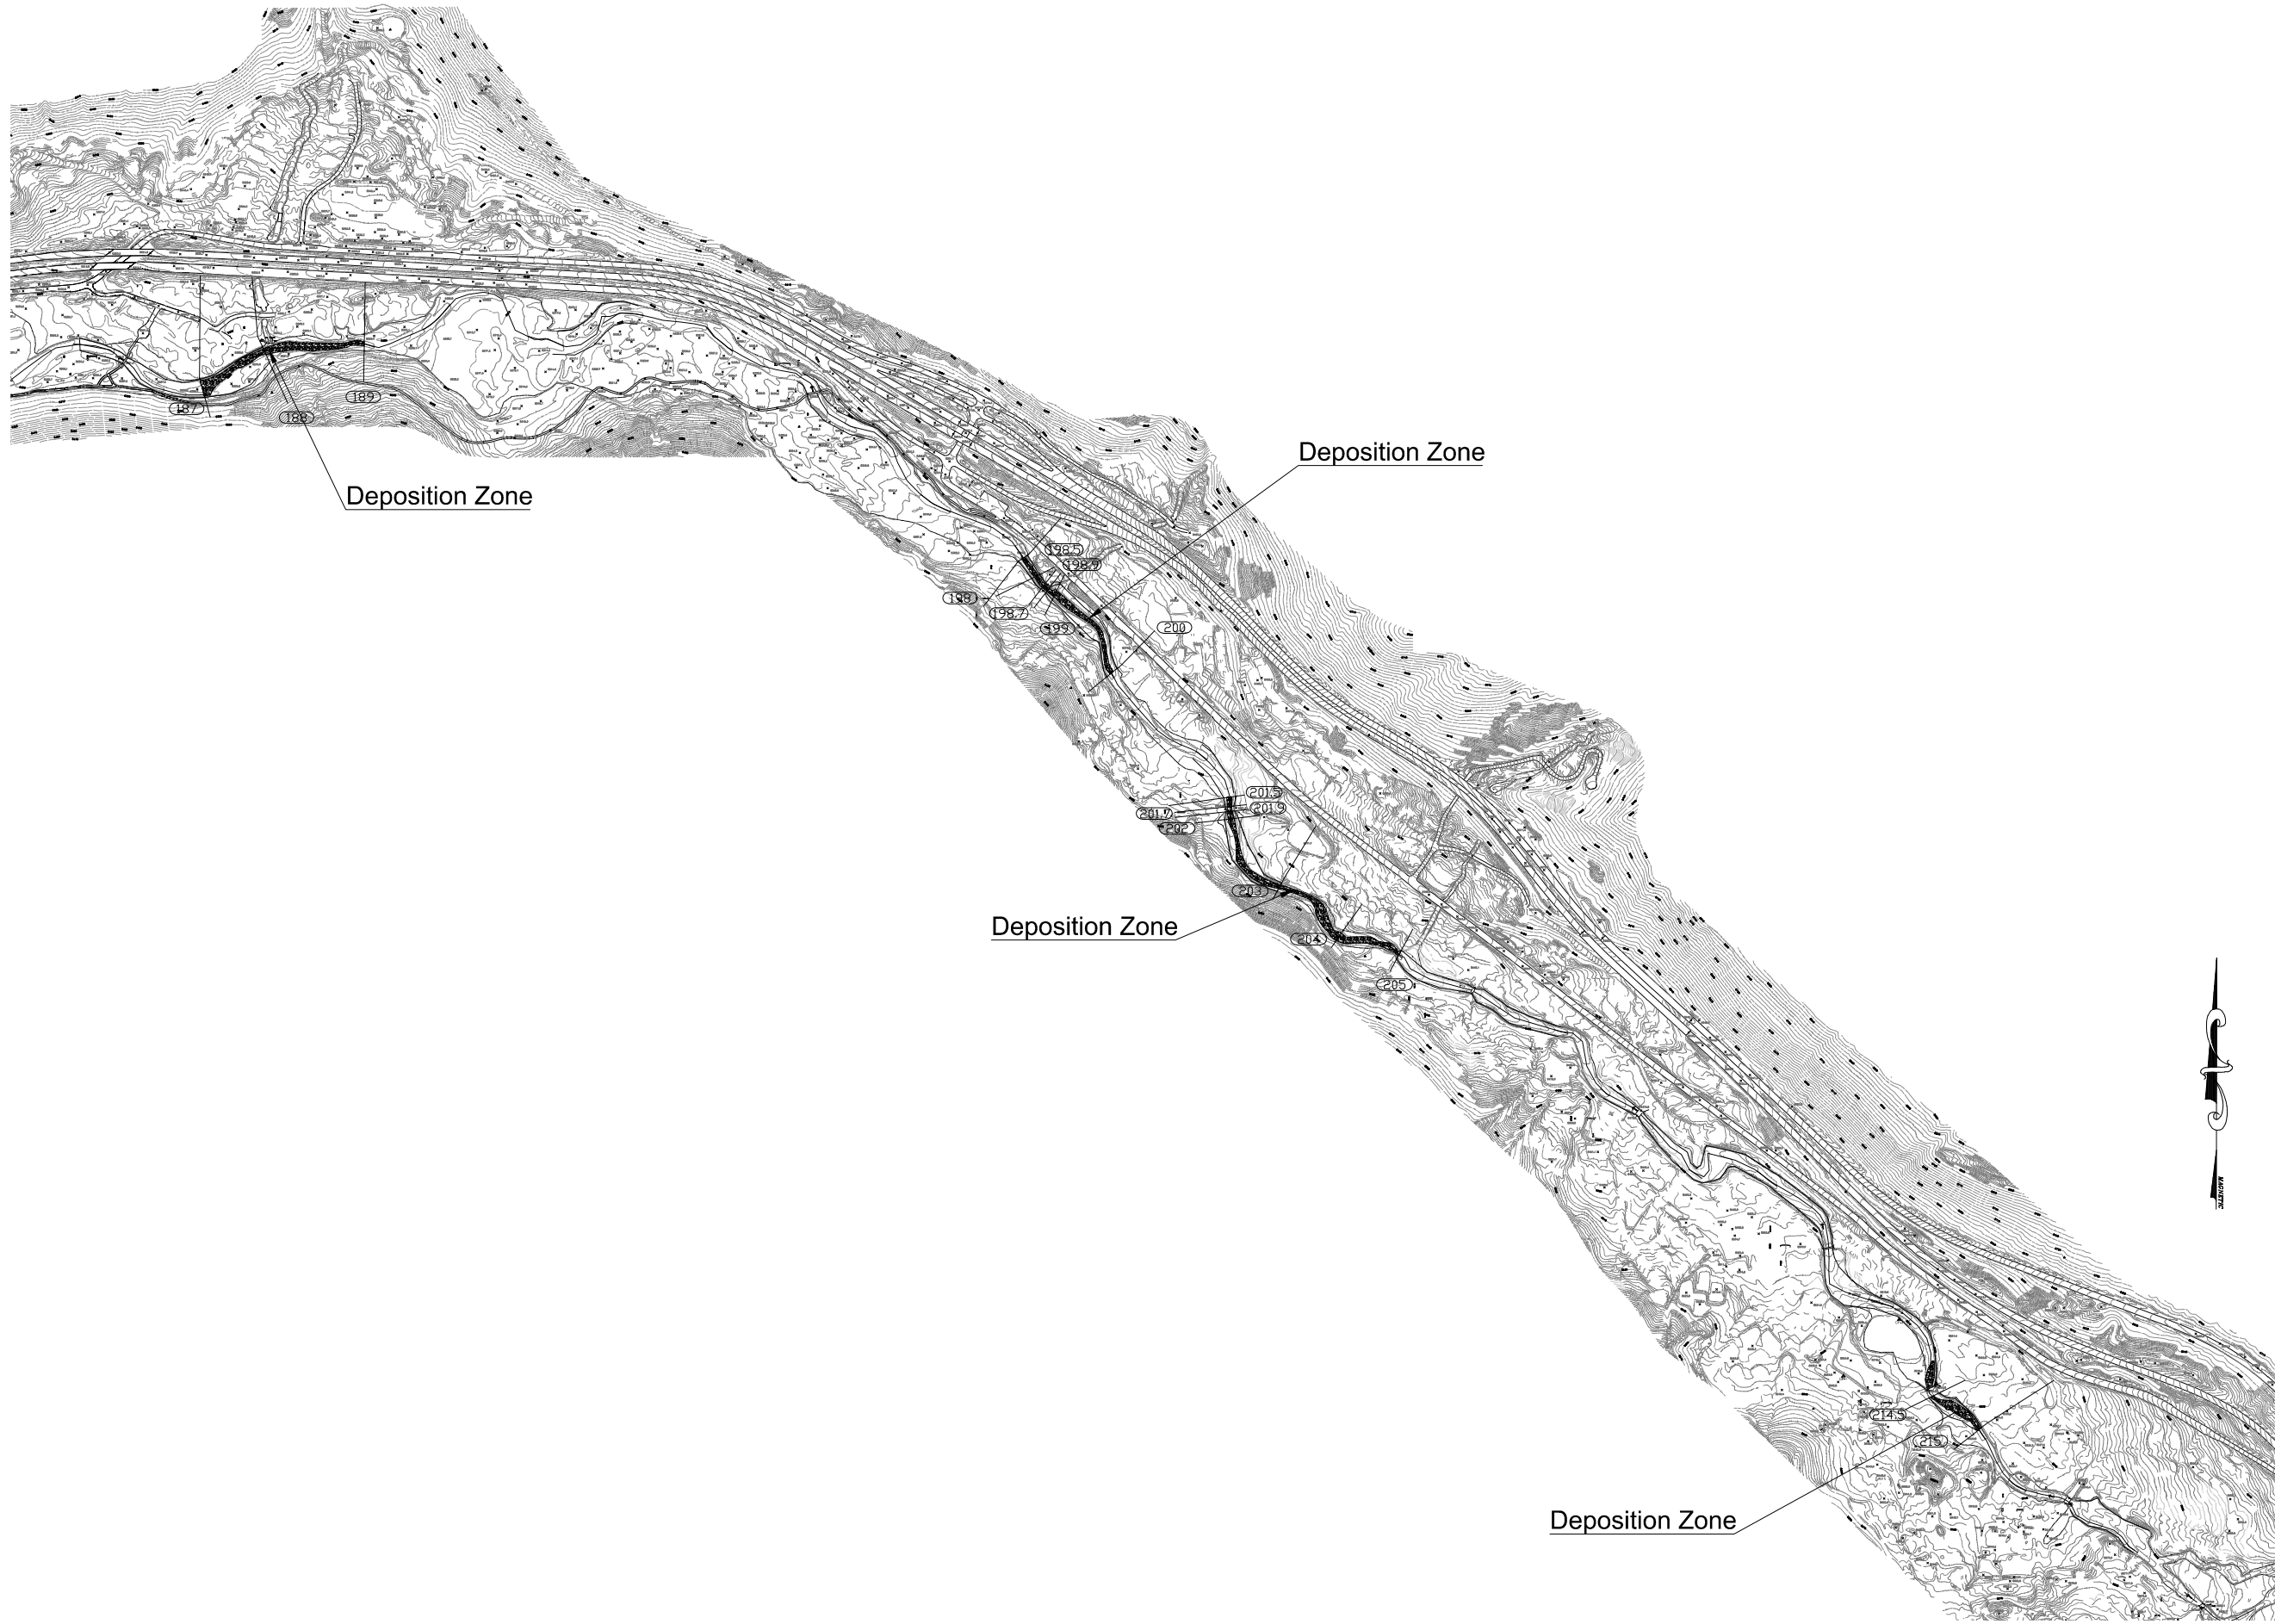
TOWN OF VAIL
 CHANNEL CONVEYANCE STABILIZATION
 SKETCH DESIGN
 PLAN VIEW

Comparing the pre- and post-event channel geometry at XS 187 shows a large amount of channel aggradation, up to 4 feet in some locations. The loss of channel conveyance area caused a rise in the predicted base flood elevation of 1.55 feet. XS 186.5 has also morphed since the effective model survey in 1995; showing channel aggradation with 40 feet of left bank erosion. Viewing XS 185 in cross-section shows the formation of a large gravel bar in the center of the channel caused by deposition of materials. The water surface elevation was raised 0.63 feet at XS 185. Approximately 3,500 cubic yards of material has been deposited between 600' above to 300' below the bridge alignment.

There are likely other areas, concentrated in East Vail, that have effective base flood elevations impacted by the significant aggradation. We recommend that survey and subsequent hydraulic analysis be repeated at: XS 187 - XS 189, XS 198 - XS 200, XS 201.5 - XS 204.7, and XS 214.5 – XS 215. Repeated survey will be the basis for evaluating existing conditions and recommending channel modification measures.

Detailed costs and sketch plans are presented in Appendix C. Recommended measures include:
