Structural Condition Assessment Report

Vail Transportation Center Parking Structure
Vail, CO

June 18, 2004

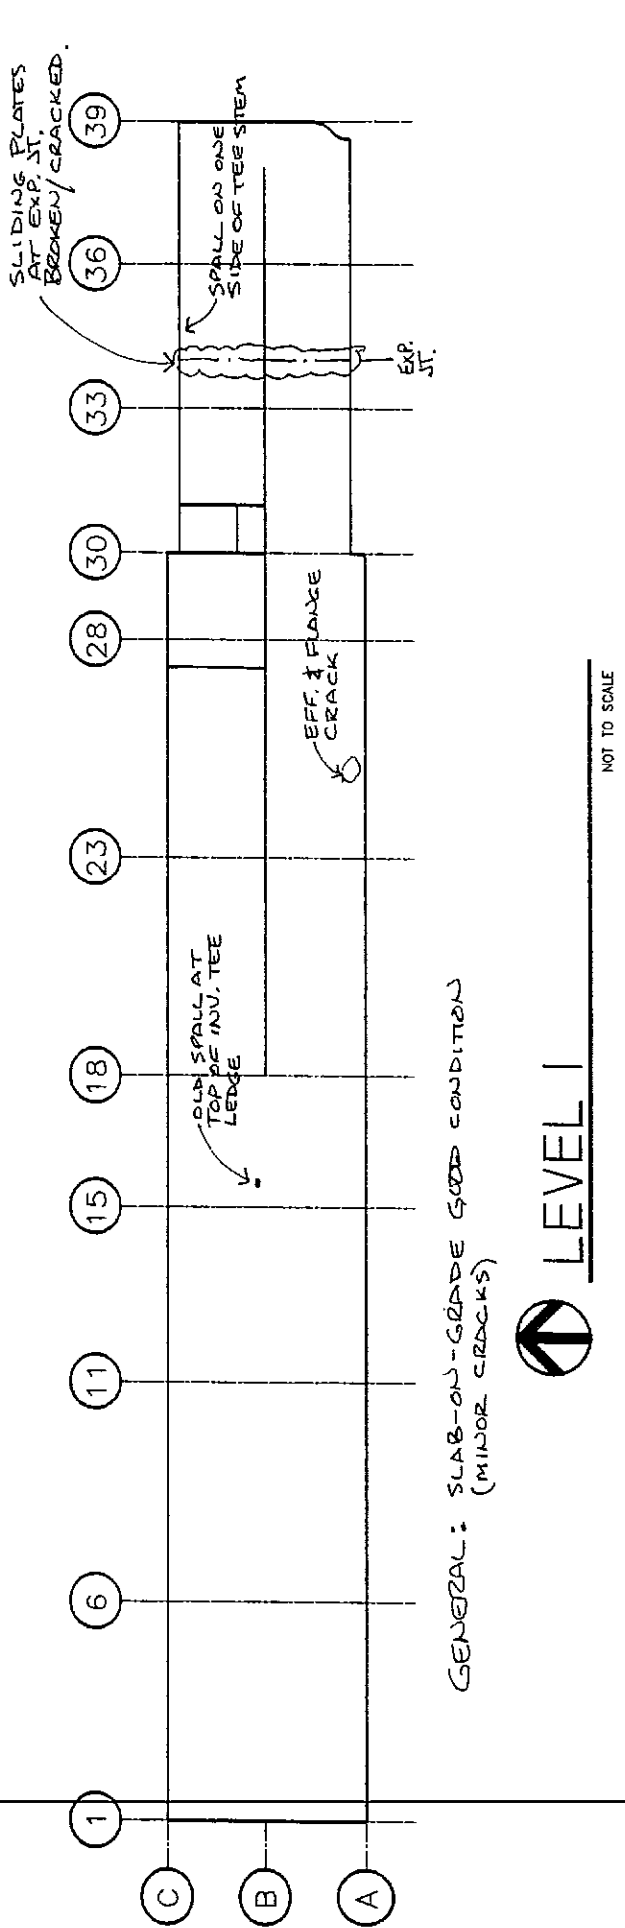
↑ LEVEL 1

GENERAL: SLAB-ON-GRADE GOOD CONDITION (MINOR CRACKS)

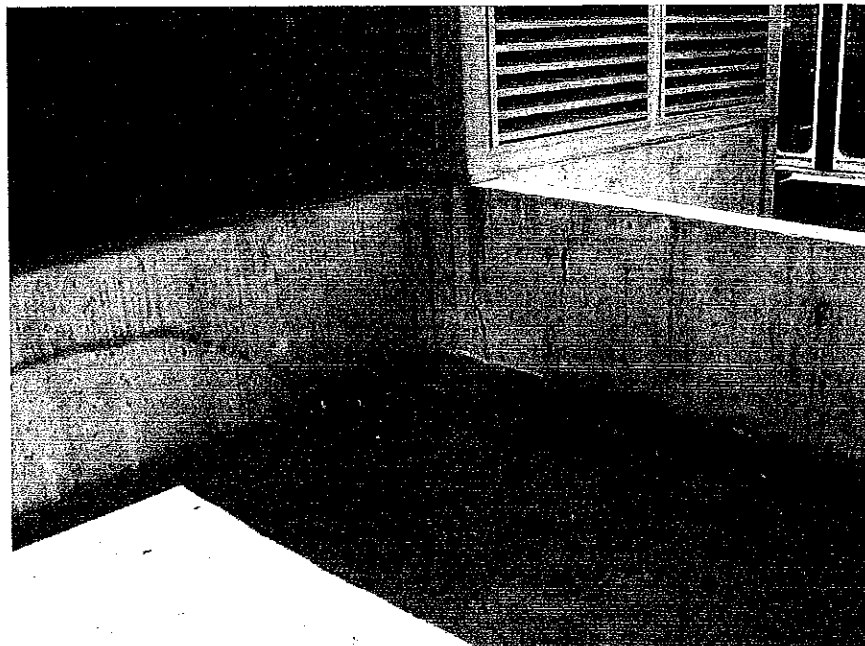
The toppings at all levels appeared to be generally in good condition. Some cracks were observed on the upper level. Various low spots where puddles formed were often associated with efflorescence and local damage to the tee flanges below. The addition of small drains at such low spots would help to alleviate this problem. The only delamination was observed at level 2, and it was all in a line, apparently associated with a rebar that had been placed too high. This area of very local distress could be either chipped out and repaired if you wish to address it now or deferred for future action. Several areas with exposed rebar or cracks over the bars were observed. These occurred on Grid 28 on both levels 2 and 4.

Photo 2. Low spot on upper level where water collects. Near Grid C/1.

- Install local deck drains in low spots where puddles form.
- Level 3:
- Repair stair-step crack in CMU wall near entrance.
 - Reset two tee bearings near C/30 (inside vent enclosure).

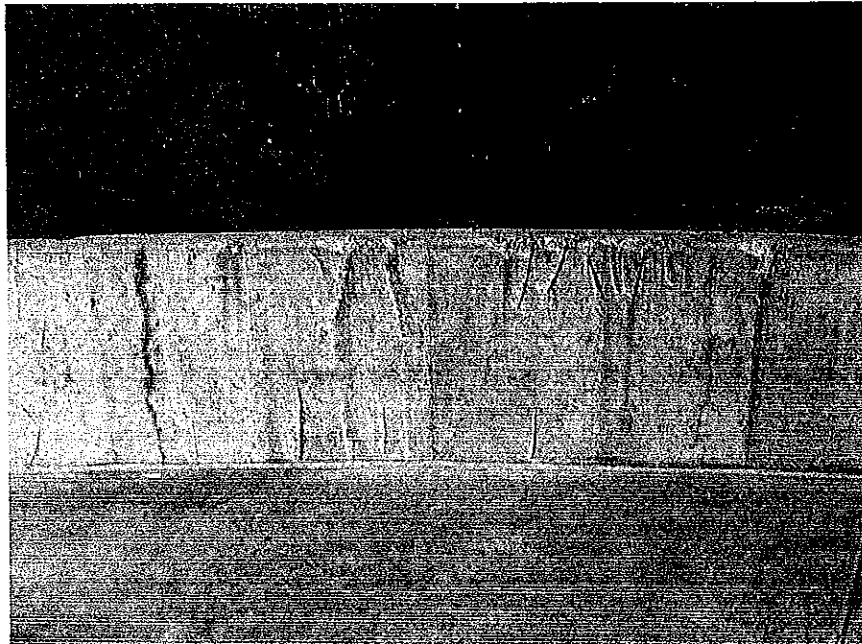
Photo 3. Minor chipping has occurred at parapet at upper level. While not a structural issue, cosmetic patches are an option.

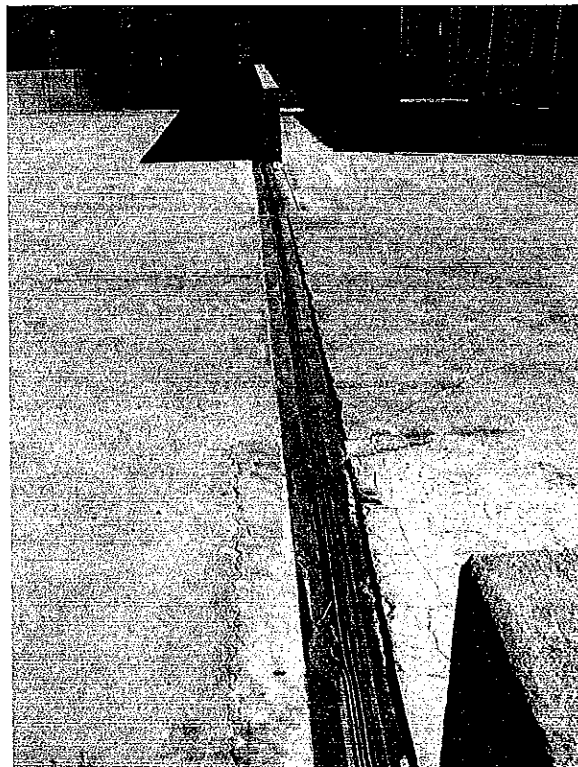
Some of the expansion joints had local damage to the elastomeric components at the surface. This was most prevalent on the upper level. The locations are indicated on the sketches in Appendix A. In one case a hole through the expansion joint was observed (near A/36). We recommend the expansion joints be repaired to prevent water from entering the structure.

Photo 4. Local damage at expansion joint on upper level.

- Upper:
- Rout and seal cracks in deck and sidewalk.
 - Repair damaged expansion joints.
 - Repair minor topping spalls.
 - Repair tripping hazard at patch near A/1.

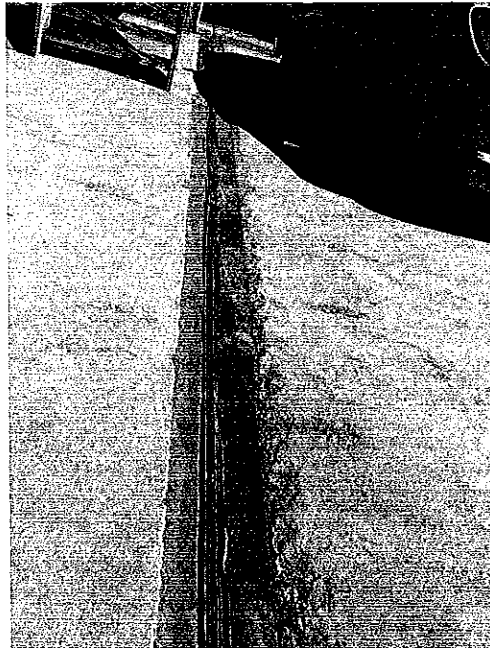
Photo 6. Deterioration at expansion joint on upper level.

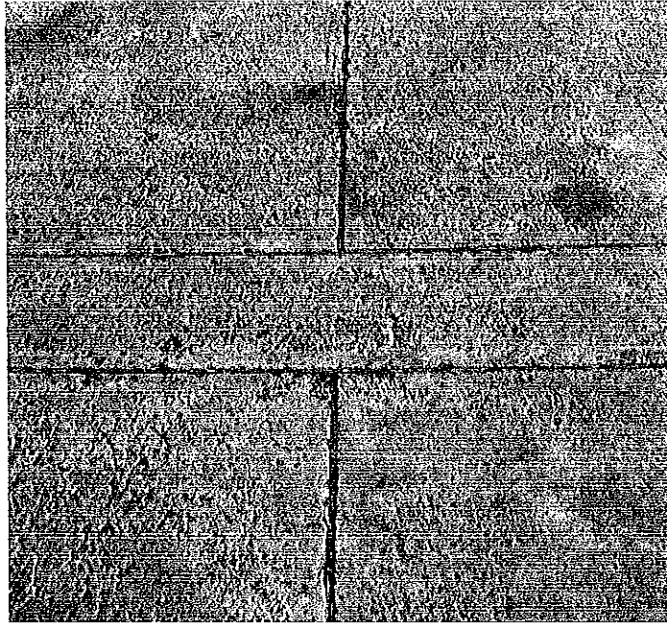
Photo 7. Typical condition of control joints on upper level. The accumulated dirt should be removed and the joints resealed.

- Power wash joints to remove dirt.
 - Remove and replace joint sealant as necessary.
 - Sandblast, prime, and paint the rusted vent enclosure near C/20.

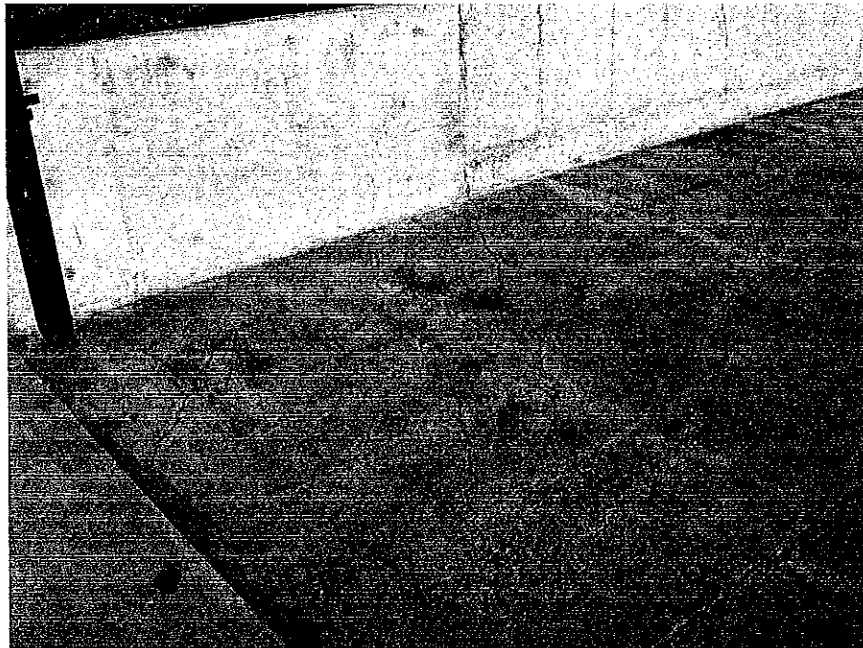
We believe some foundation settlement has occurred near the SW corner of the structure (near A/1). The upper level topping cracks in this area, the separation crack between the tunnel and the parking structure at level 2, and the minor distress at the exterior wall at this area at level 3 all point to some small settlement in this area. We do not consider this a cause for concern; but it is reasonable to project some future distress (again minor), with associated minor maintenance repairs, due to minor foundation settlement.

Photo 8. Cracks in upper level topping topping near A/1. They should be routed and sealed.

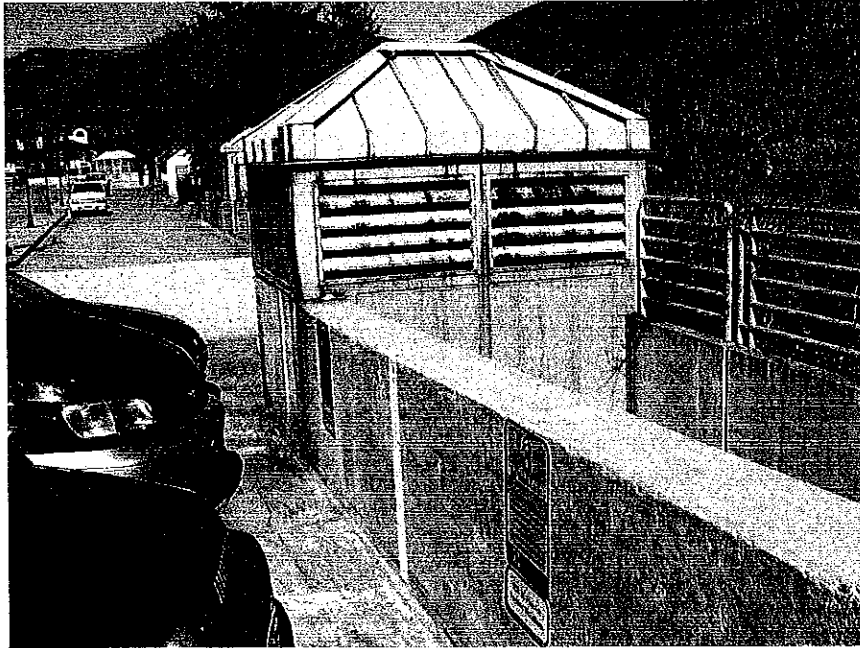
Photo 9. Exterior of ventilation enclosure near C/20. this is the only such enclosure in rusty condition. It should be sandblasted, primed, and painted.

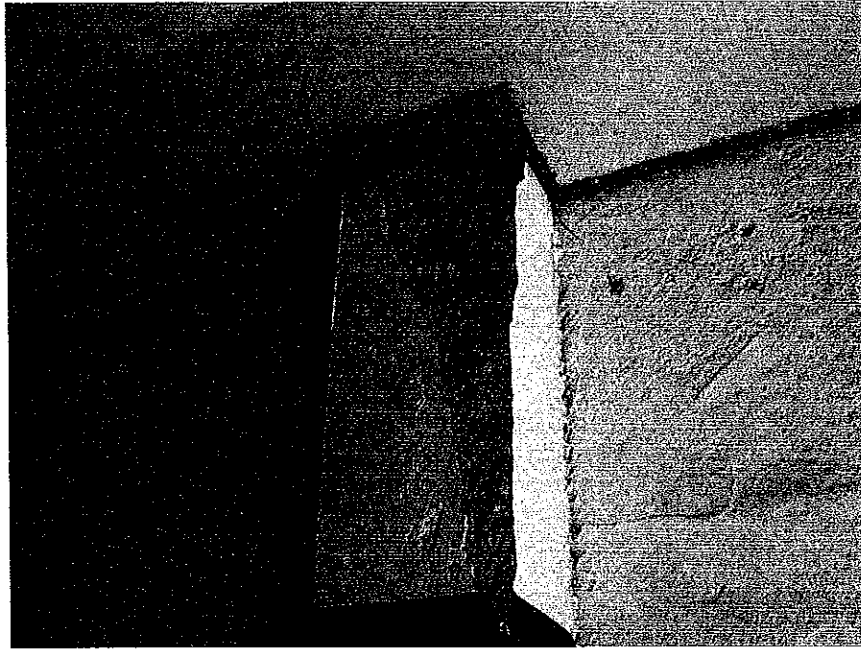
One pilaster, located on level 3 near A/29, had some large cracks. We hammered at the cracked area, and removed the loose concrete. The pilaster formerly acted a flexural member (it served as a stiffening rib) when the wall was subject to lateral pressure from soil. But the addition of an elevator lobby has removed the lateral pressure from this element. We suspect the top-level slab, which was placed over the top of the pilaster, has moved slightly, pulling on the pilaster at its top. This could have precipitated the cracks. We do not believe the crack is a cause for concern. Structurally, the pilaster is acceptable "as is". It should be patched simply for cosmetic reasons.

Photo 11. Spalled pilaster near A/30 in elevator lobby of level 3. There is no structural issue here; the pilaster may be patched and painted to match for appearance.

- Tighten loose nut at tee stem hanger near C/19.
 - Repair spalled concrete at pilaster in elevator lobby near A/30.

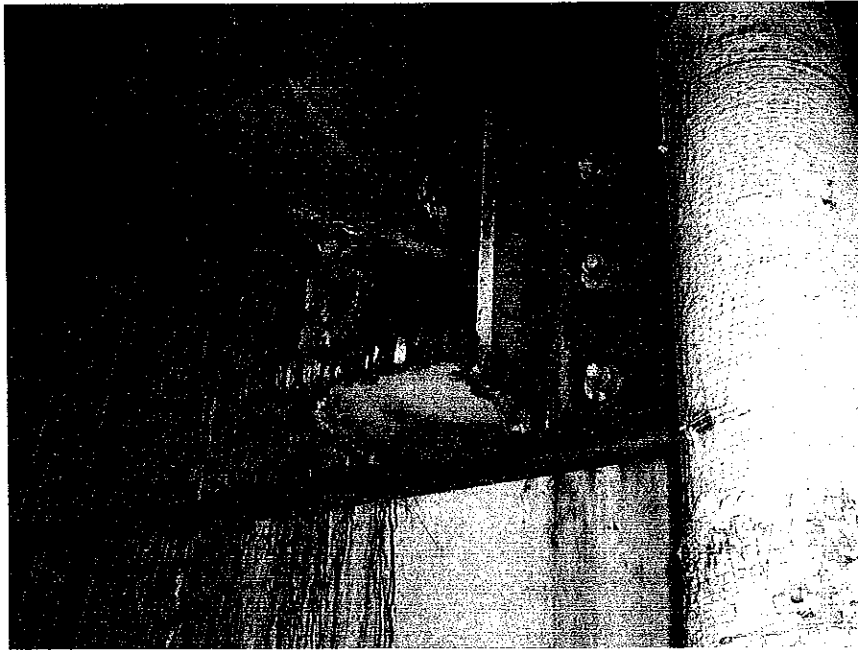
The stems of two upper level tees, both located in the ventilation room near C/30, appear to have "walked" somewhat off the original bearing position. Remedial action would be appropriate here. The stems should be jacked up, the shim stacks repositioned, and the bearing pads replaced.

Photo 13. Tee stem has “walked” off its bearing location inside ventilation enclosure near C/30. This is typical of two. Both should be reset.

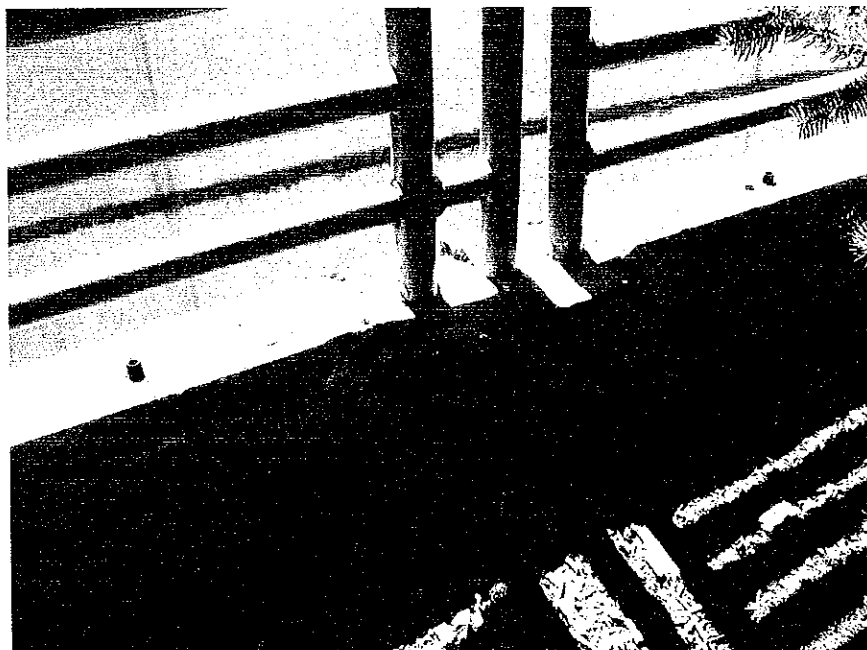
Photo 14. Connection of railing post to concrete wall is deteriorated. This is a typical condition along C from 20 to 30. The connection should be repaired.

- Reinstall louver below the vent enclosure near C/20.
 - Repair railing base connections along C/23 – C/28.
 - Repair roof flashing near C/29.
 - Install bolt at railing post on stair landing near A/11.

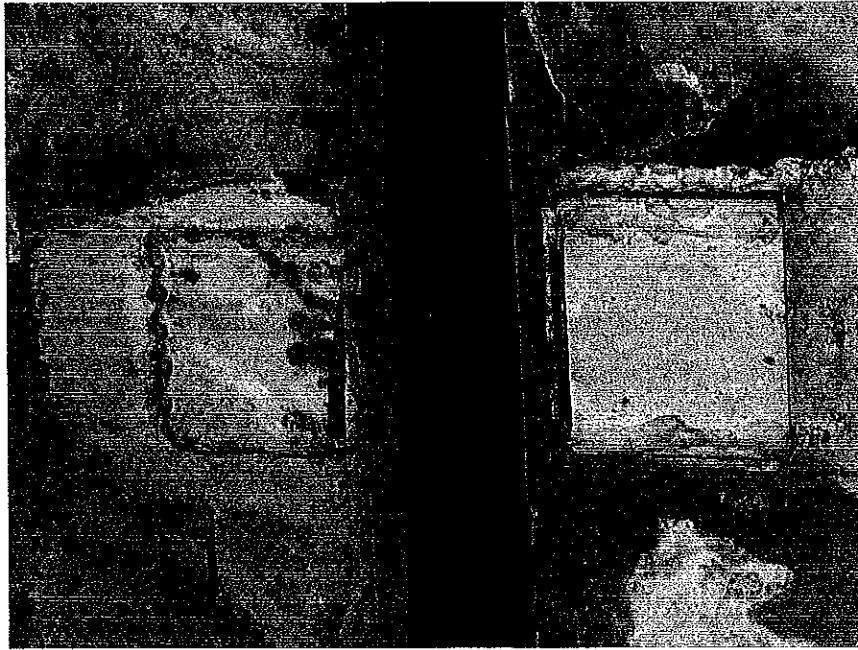
The sliding devices, made from short rectangular steel tubes, at the underside of expansion joints in the original part of the structure appeared somewhat rusted, but functional. On the other hand, the sliding plate devices at the underside of expansion joints at the addition to the east were damaged. These sliding plates, both at the undersides of the expansion joint near grid 34 above levels 1 and 2, were cracked and broken. The tees flexed noticeably when a vehicle drove over the expansion joint. See photos in Appendix B. These connections transfer wheel loads across the expansion joint, thereby protecting the joint seal from excessive movements and the deck from impact load. They may also transmit some in-plane force parallel to the joint. They need to be repaired. The replacement should be designed to be stronger than the original design.

Photo 17. Photo 16. Sliding plate expansion joint device at expansion joint in the addition near grid 34. The plate is broken.

- Level 2:
- Repair loose floor seal at B/28.
 - Repair loose sealant near B/30.
 - Repair sliding plate devices on expansion joint near 34.
 - Repair topping delamination 23 – 28, between A and B (optional).
 - Install local floor drains in low spots along A/23 to 28.
 - Install local floor drain in low spot near C/15.
 - Patch cracks in tunnel wall and in retaining wall, both near A/1.
- Level 1:
- Repair sliding plate devices on expansion joint near 34.
 - Rout and seal minor cracks in slab-on-grade.
