## 6.0 Appendix

# 6.1 EXISTING CONDITIONS PHOTOS

**GEOLOGIC HAZARDS REVIEW  
PROPOSED TOWN OF VAIL  
PUBLIC WORKS FACILITY DEVELOPMENT  
1309 ELKHORN DRIVE, VAIL  
EAGLE COUNTY, COLORADO**

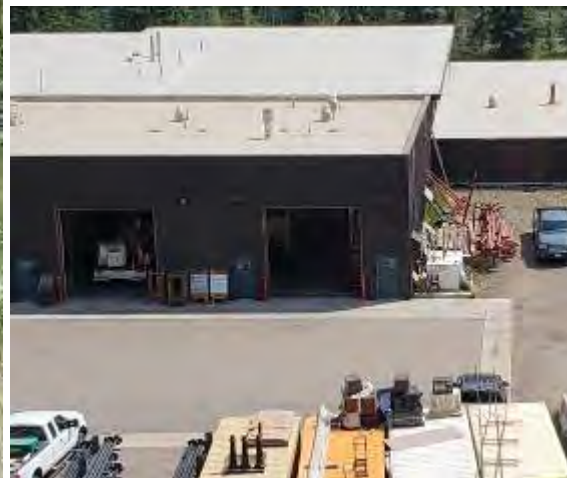
View from 2<sup>nd</sup> utility transformer feeding the Maintenance building.

It's unusual to have transformers located away from commercial properties. We normally locate transformers as close to the buildings as possible to minimize voltage drop. Utilities also have a policy to have ready access to their utility transformers incase replacement or maintenance is required. The existing utility transformer locations are not readily accessible, there's a rough jeep trail providing access.

- I. Overhead pole utility power is routed around the north and west portions of the property. The power poles and utility transformers are located up the mountainside. Services to the buildings are adequate. It would be recommended to set utility transformers closer to the buildings and provide better utility access to transformers for maintenance and replacement in case of emergency.

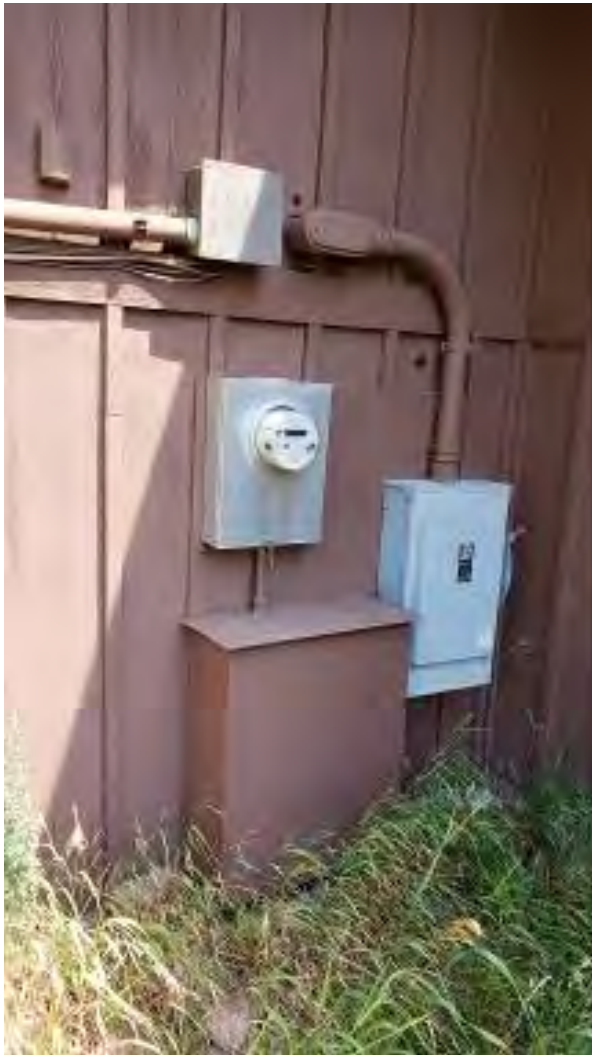
The Administration Building meter and main disconnect are located near the center of the north side of the building. The 200 amp 120/208V 3P disconnect has a short run of wire to the interior main power panel. The main power panel distributes to two other sub panels. The service and power distribution are adequate, the power panels are in fair to good condition.

**Administration Building incoming service CTs and Main Disconnect**

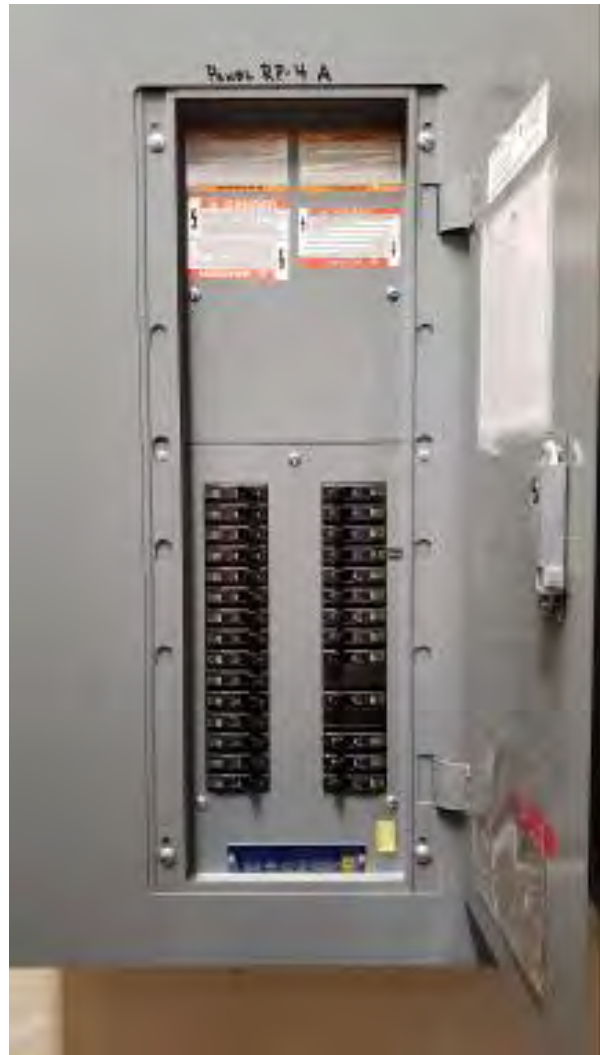
**Administration Building Main Power Panel.**

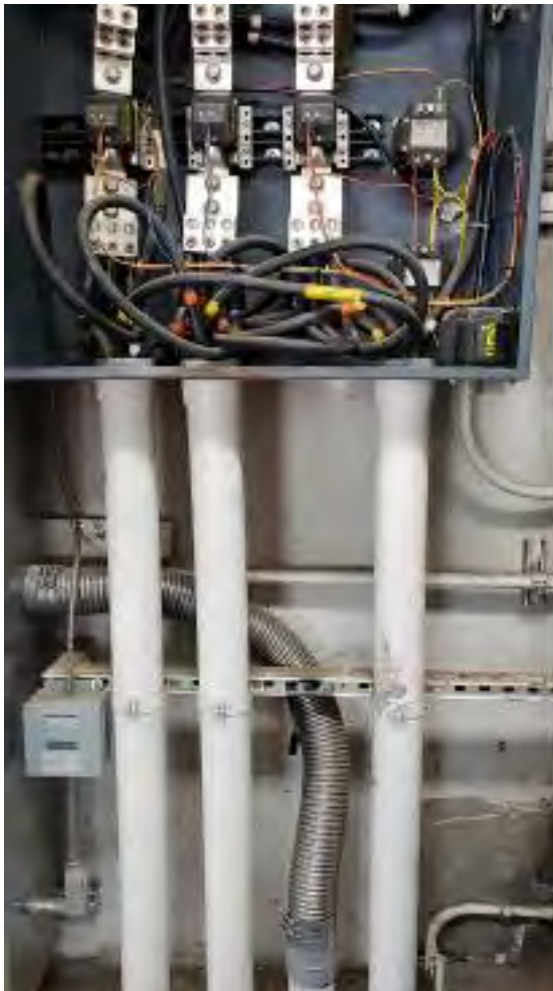
**Maintenance Building incoming service splice at CTs**

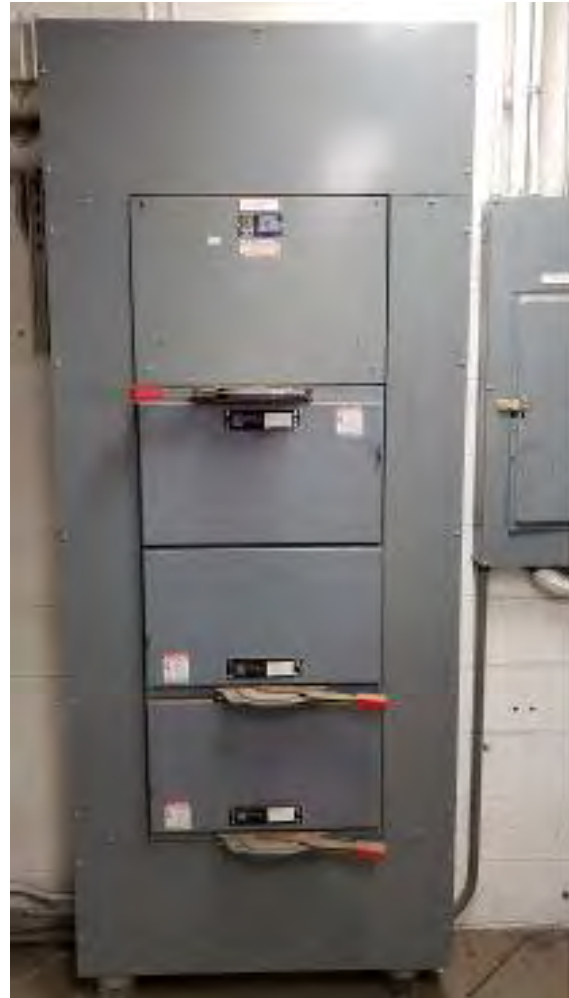
**Maintenance Building Main Distribution Panel, one of two.**

These main distribution panels feed the power panels throughout the Maintenance Building. Most panels are in fair shape, some poor and in need of replacement. The panels are located as far as 500' when you've run to the other end of the building where the fleet fueling station is. There would be a concern for voltage drop when running this long of a distance.

The incoming service is not heavily loaded. During any new construction any opportunity to improve the main distribution at the incoming service, add a service at the far end of the building and replace existing panels during new construction should be pursued.

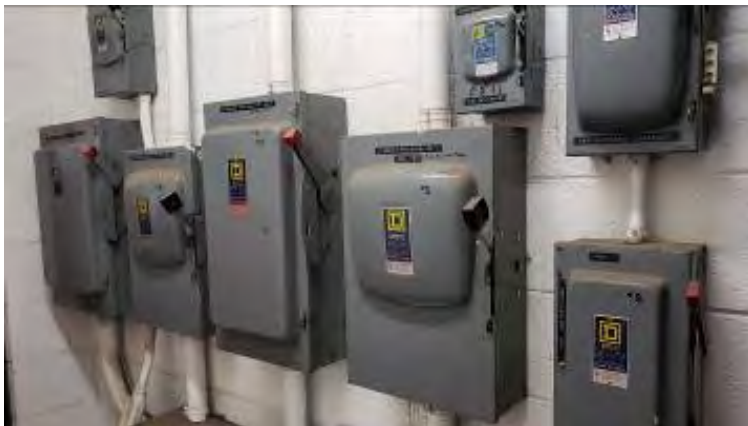
**Maintenance Building old gutter and disconnects**

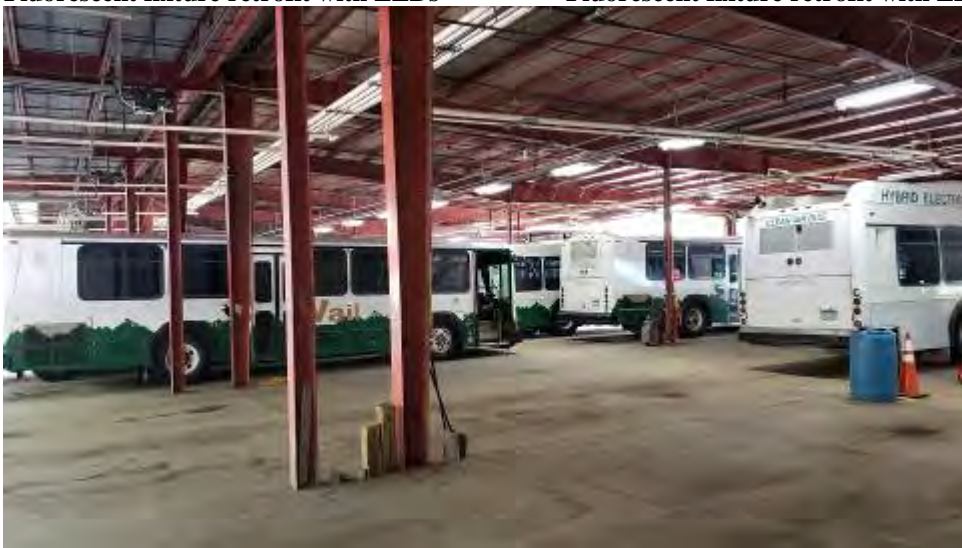
**Bus storage area LED lighting with motion sensor control.**

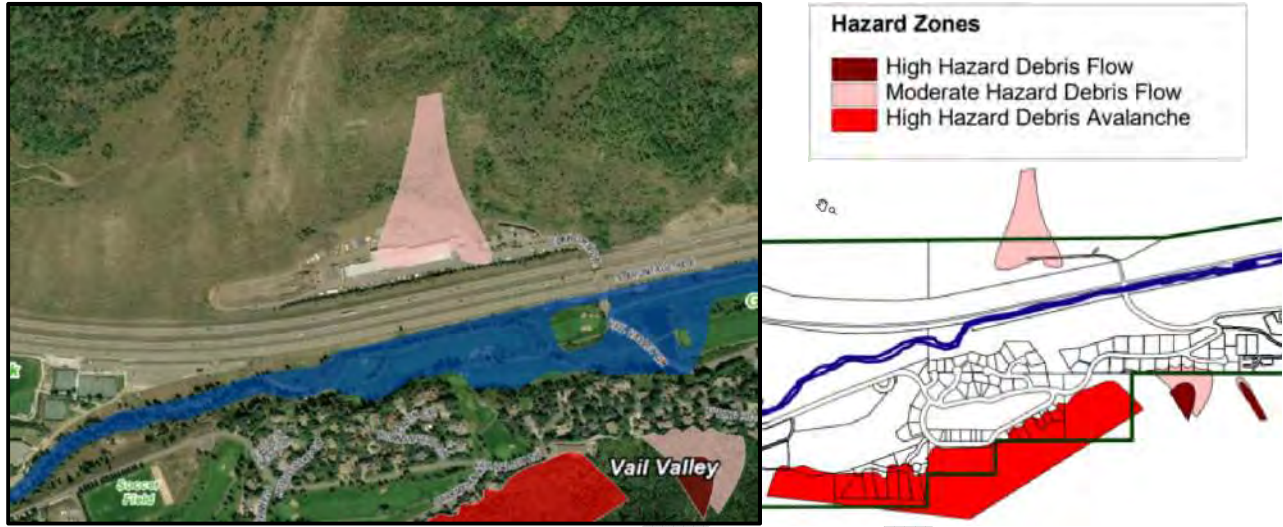
Figure 3: Debris Flow Hazard Map

The existing project site lies within a debris flow hazard zone and rockfall hazard zone. There is no documentation in the existing drawings to indicate that the existing buildings were designed to consider these hazards. In the event of future site expansion a geologist should be consulted to give recommendations to control rockfall and debris flow (Figure 3 and 4).

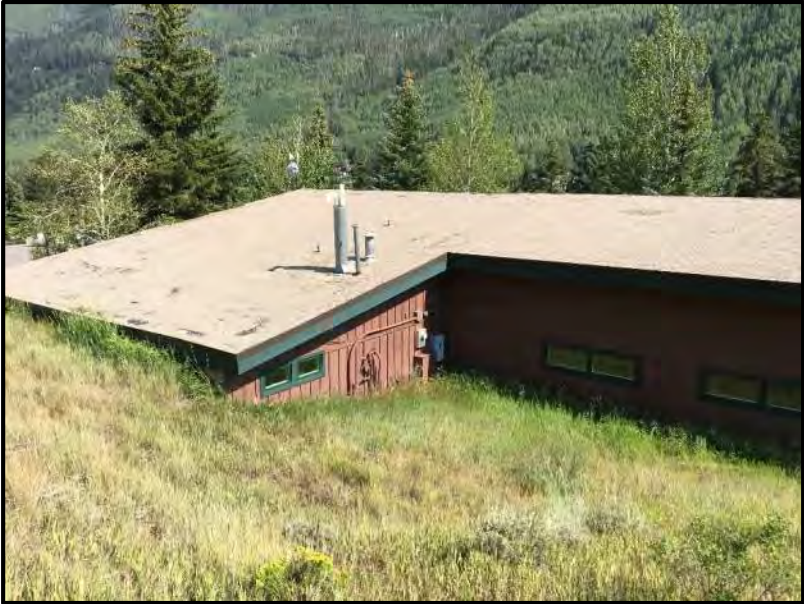
Photo 1: North Side of Administration Building Looking South

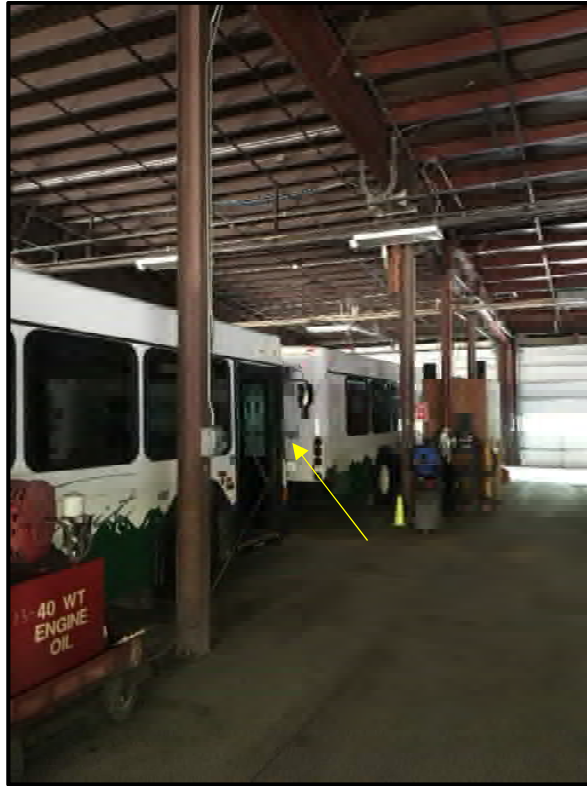
Photo 3: Tension Only Steel Cross Brace Missing Tension Tie

At locations where it was discovered that tension only steel cross braces have been removed, the braces should be re-installed back to the assumed original condition.

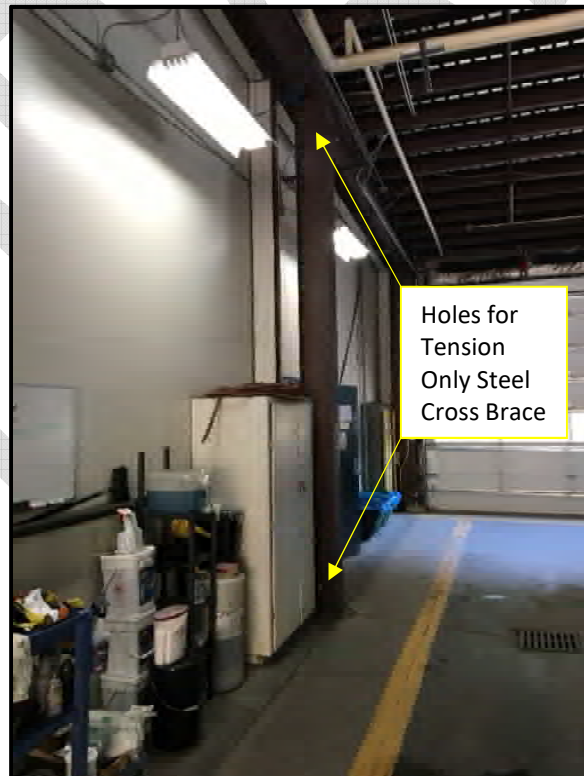
Photo 4: Missing Tension Only Steel Cross Braces

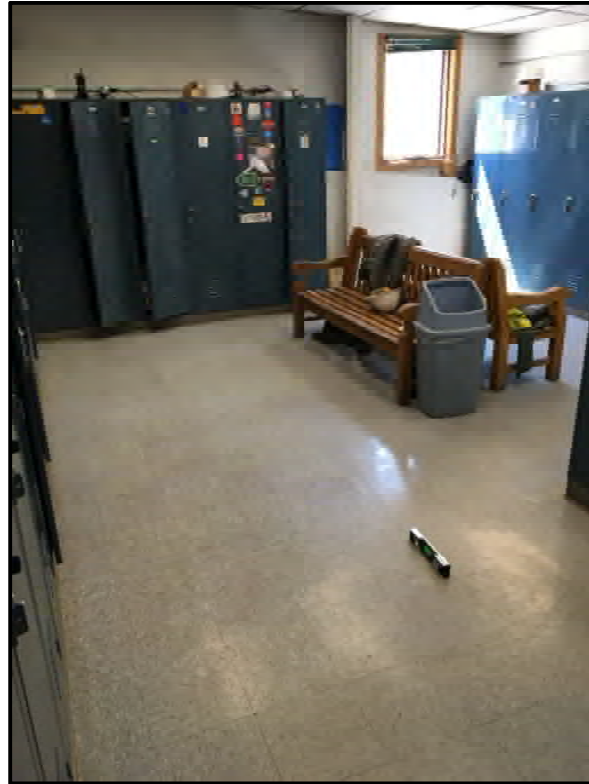
At the mezzanine there was a noticeable hump in the locker room floor which is supported by slab on metal deck (Photos 5 and 6). Also, in the mezzanine there were cracks in the slab on metal deck at the break room that extended both north/south and east/west (Photos 7 and 8). The mezzanine slab on metal deck is supported by joists and joist girders, however the parts room directly below this area was not accessible at the time of our visit.

Photo 5: Hump in Mezzanine Locker Room

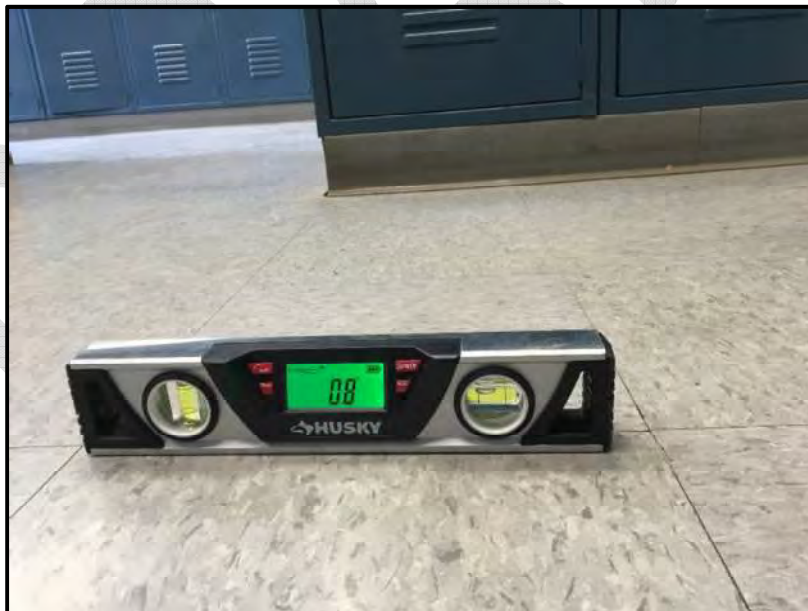
Photo 6: Hump in Mezzanine Locker Room

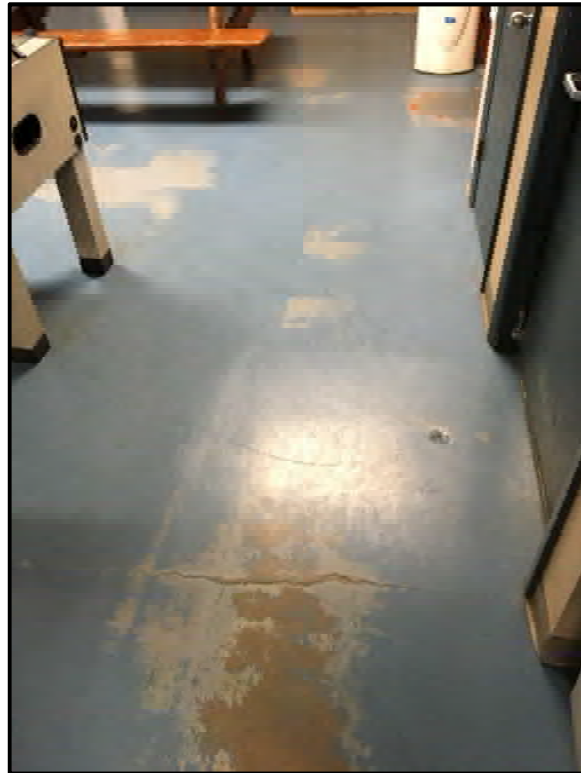
Photo 7: Cracking in Mezzanine Slab on Metal Deck at Break Room

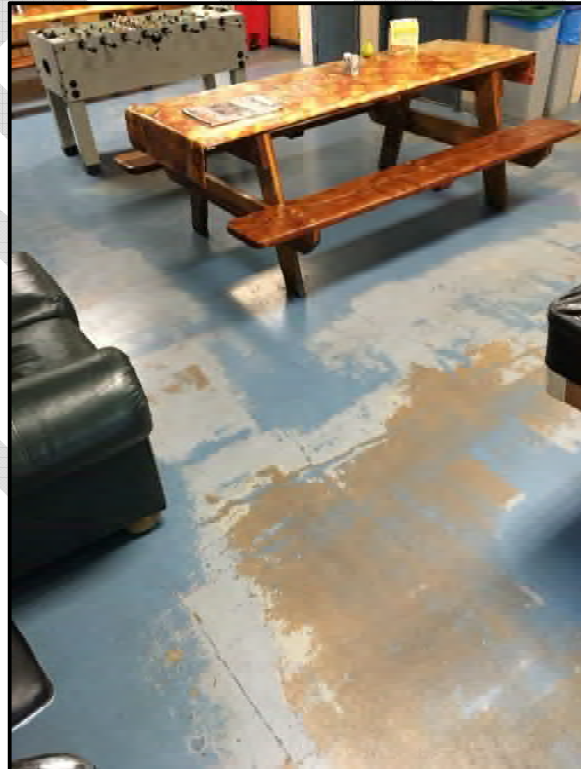
Photo 8: Cracking in Mezzanine Slab on Metal Deck at Break Room

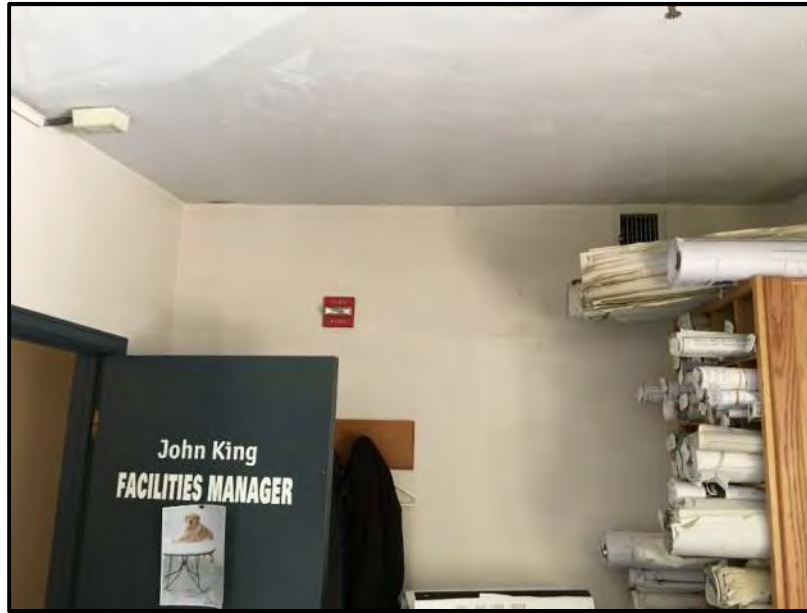
Photo 9: Crack Between Ceiling and Wall in Mezzanine Office

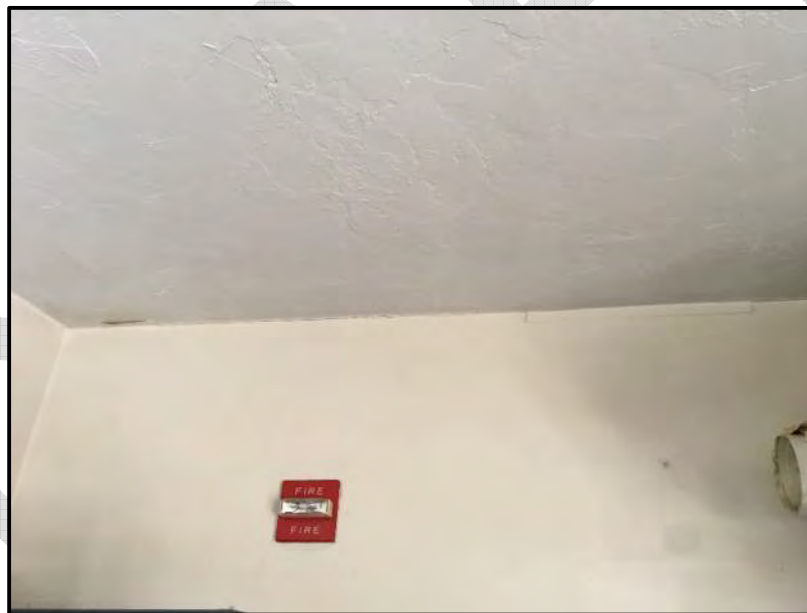
Photo 10: Crack Between Ceiling and Wall in Mezzanine Office
