**DRAFT
ROCKFALL, AVALANCHE AND
DEBRIS FLOW HAZARD
AND RISK ASSESSMENT**

**TOWN OF VAIL TRAIL
IMPROVMENTS AND EXTENSION
EAGLE COUNTY, COLORADO**

April 26, 2016

Re: DRAFT Report - Avalanche, Debris Flow and Rockfall Hazard Impact Assessments
The Vail Trail Proposed Improvements and Extension, Vail, Colorado

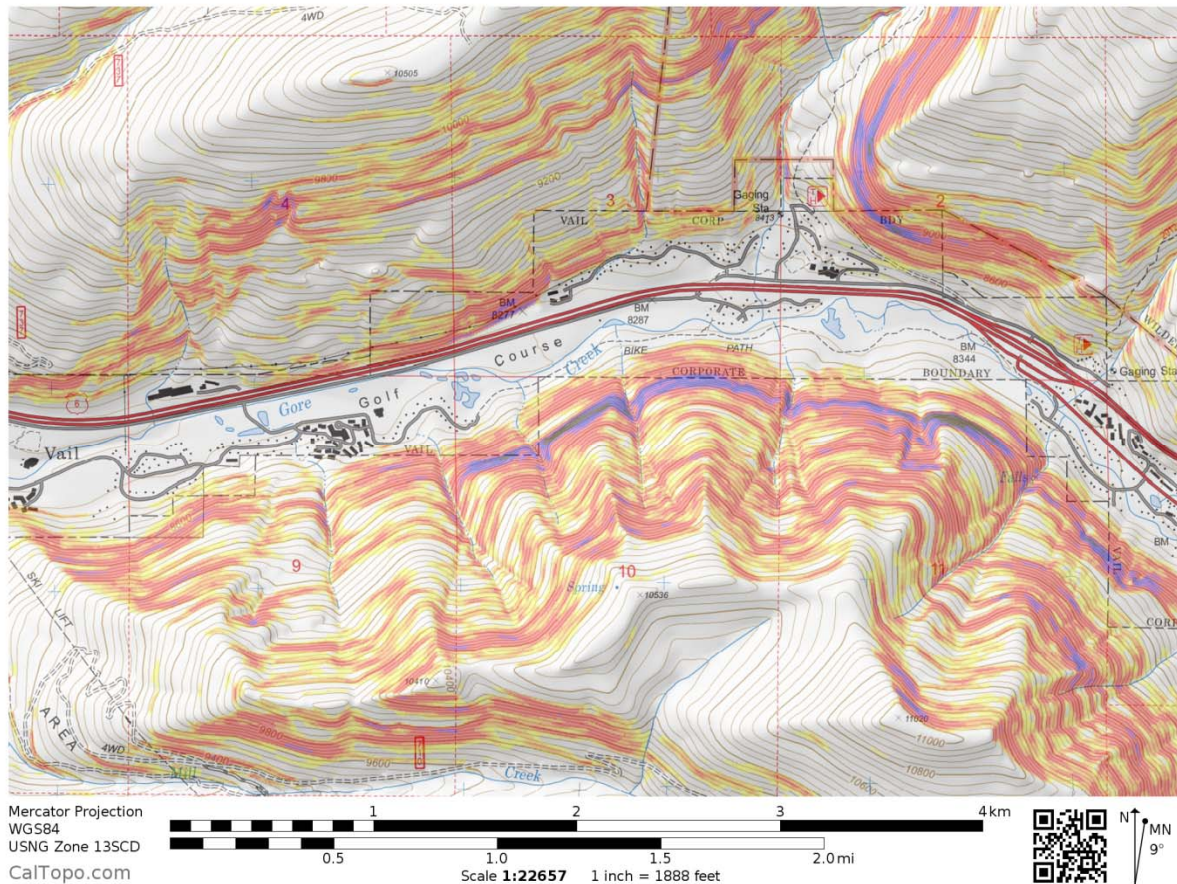
Figure 2 – Trail Alignment and Buildings on CalTopo Slope Shaded Topographic Map

Figure 2 shows the project area on a topographic map shaded to indicate slope steepness. The slopes above the trail extend from 1200 to over 2100 vertical feet above the site with typical slope angles of 25 to 45 degrees. The trail alignment crosses slopes ranging from

17 degrees above Vail Valley Drive to 38 degrees above Golf Terrace. A series of cliffs bands exists above most of the trail. At the west end cliffs are about 40 feet tall and their bases are about 500 feet above the trail. The eastern section of the trail has 100-foot tall cliffs about starting about 600 vertical feet above the planned trail alignment. Existing buildings shown in Figure 2 are set back from the steep slopes varying distances, but many lie within the range of debris flows, rockfall and snow avalanches. The entire planned trail extension and re-alignments are within these mapped hazard zones.

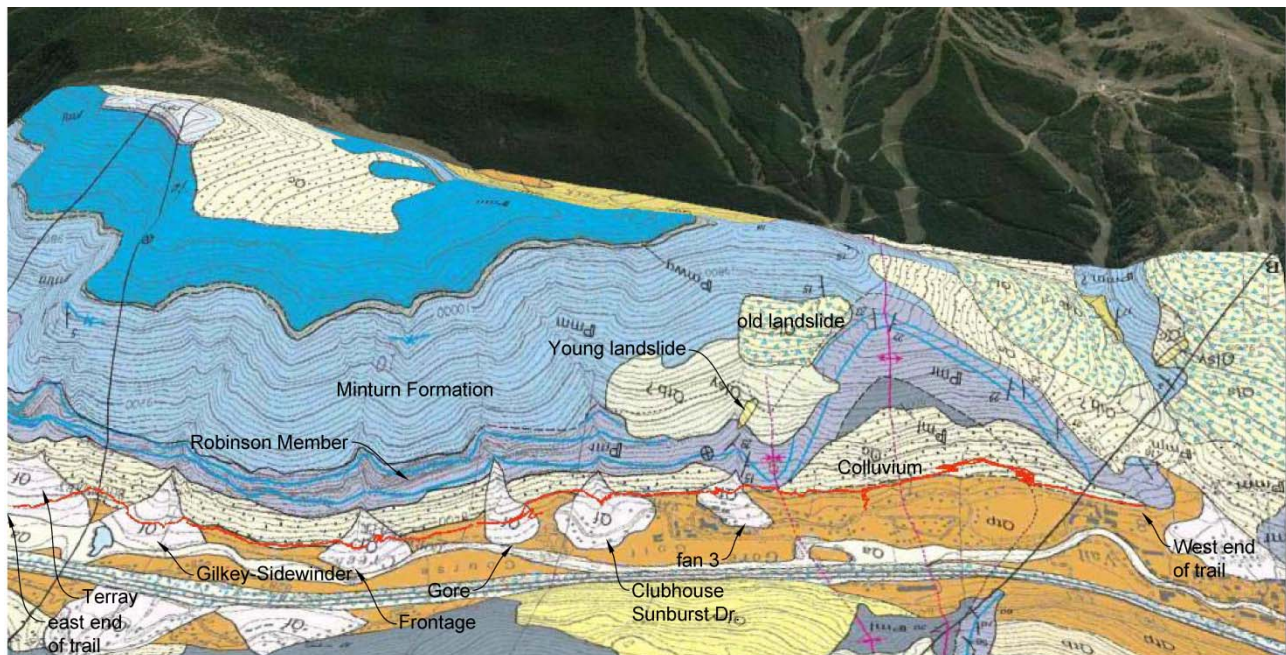
Figure 3 –Aerial view of Trail and Geologic Map Draped on 30m Digital Elevation Model
(The view is looking south and the map source is modified from Ref.2)

Figure 3 shows a geologic map of the south side of the Vail Valley and the planned trail location. The Vail Valley exhibits the classic U-shape caused by alpine glaciation that originated in the Gore Range to the northeast. The glaciers retreated from the valley about 15,000 years ago at the end of the Pinedale glaciation. Since that time other slope and channel erosion processes have altered the terrain. Those processes include both minor

At the west end of the project the upper slopes include glacial till (Qtb in Figure 3) along with old and young landslide deposits above Fan 3.

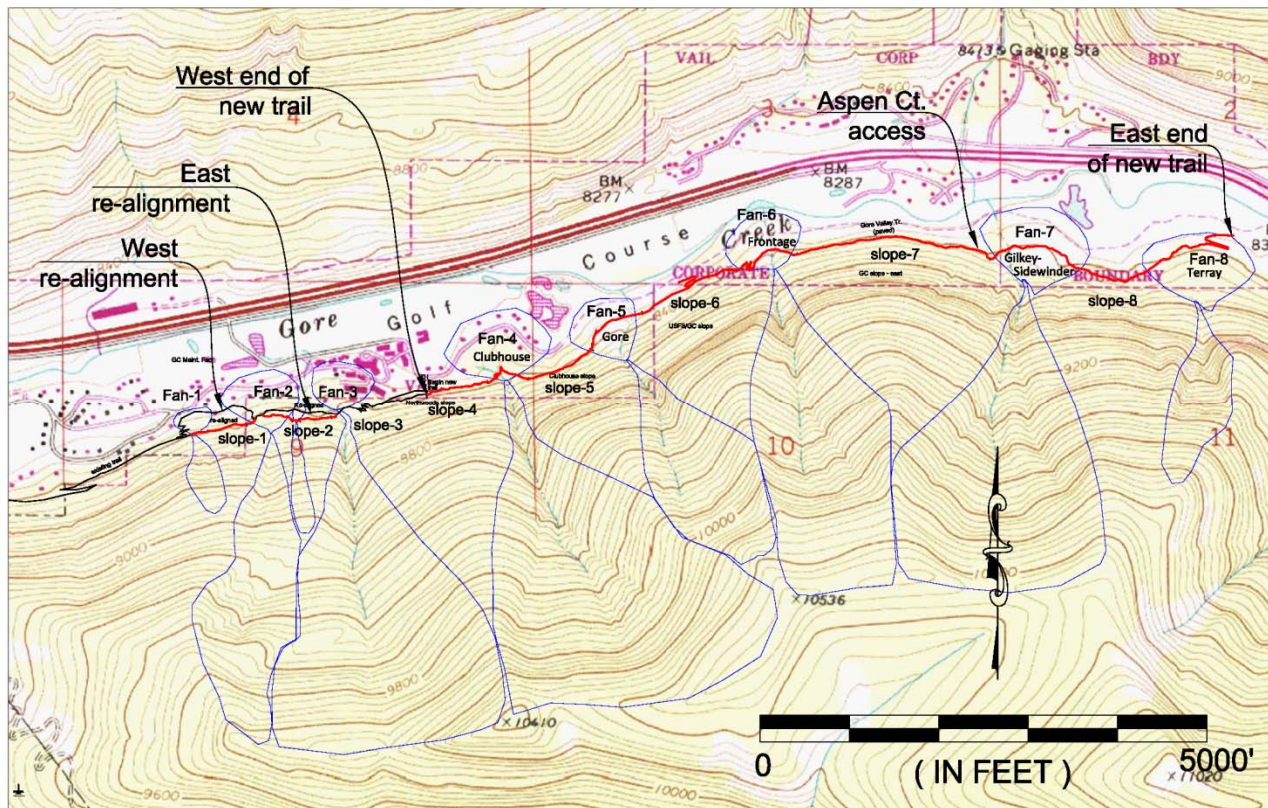
Figure 4 –Trail Segments

We divided the trail sections into two categories, based on landforms. For description purposes, segments are classified as either *colluvium slopes* or *debris fans*. Both landforms can be impacted by all types of geologic hazards, but some general distinctions can be made. For example, colluvium slopes tend to be steeper and will have higher rockfall energies and bounce heights than debris fans, assuming similar sources of rockfall. Large high speed long runout avalanches with a powder component are limited to debris fans below channelized basins that extent 1500 to 2800 feet above the valley floor. Smaller, slow-moving wet avalanches occur on colluvium slopes between the debris fans with relatively high frequencies (1 to 5 year return periods). Much larger wet avalanches can also occur in the larger basins, but these will usually stop before reaching the debris fans. Also debris avalanches of snow, soil, vegetation occur on colluvial slopes. Some large wet avalanches can also reach the fans after starting in upper slopes. Fan 3 and Clubhouse are recent examples.

2. In areas with the greatest concentration of resources exposed to geologic hazards (from Debris Fan 1 to Debris Fan 4 on Figure 4), we recommend a trail cross slope into the hill between 5 and 10 percent to achieve a high level of energy dissipation for rockfall impacts.

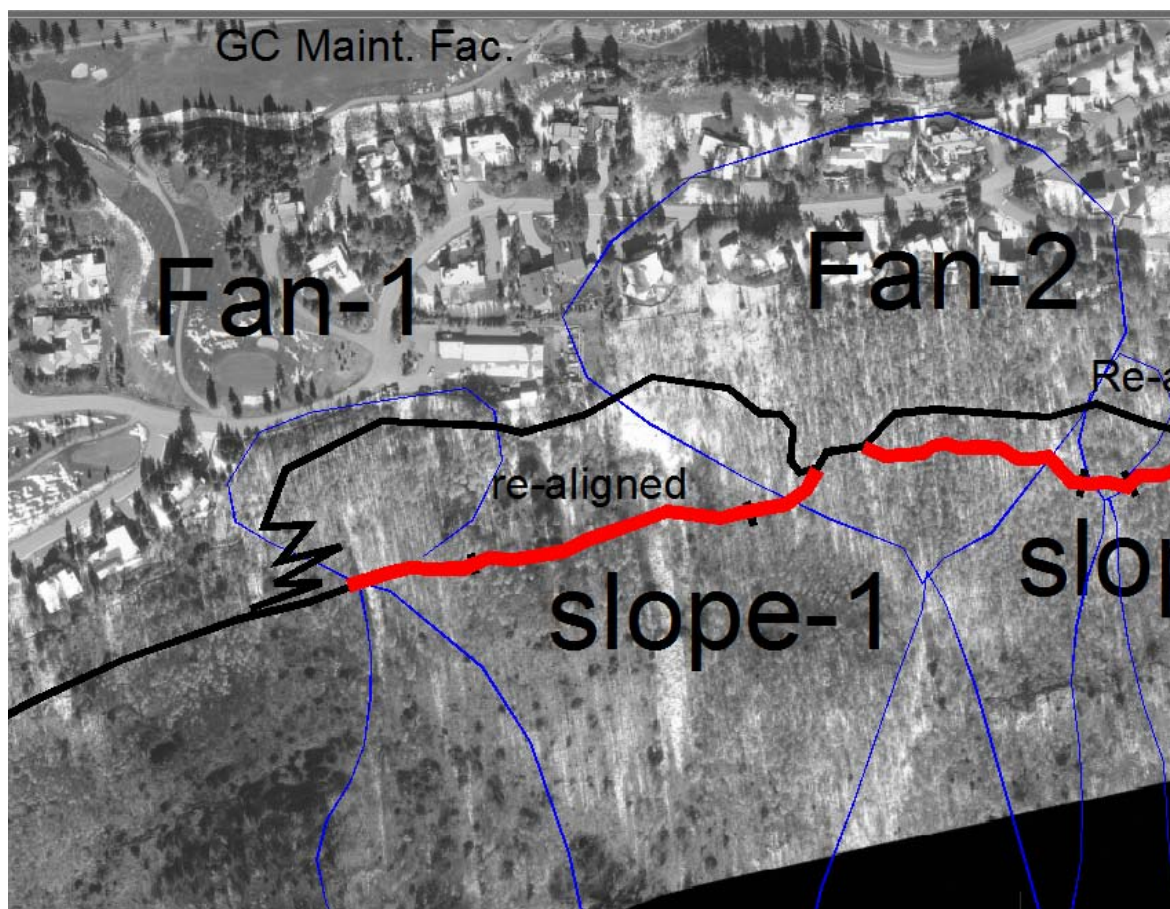
Figure 5 – 1998 Aerial from Debris Fan 1 to Debris Fan 2

Fan 1 is the smallest debris fan with the smallest basin in the project area. The proposed trail realignment would move the trail from the lower part of the fan to near the apex of the fan. Vegetation patterns (Figure 5) and topography indicate that the new portion of the fan will be subject to greater erosion and deposition at the new location than the existing location.

Vegetation clearings shown in Figure 5 indicate that the realignment to higher on the slope will result in more frequent debris and snow avalanche processes crossing this segment of trail.

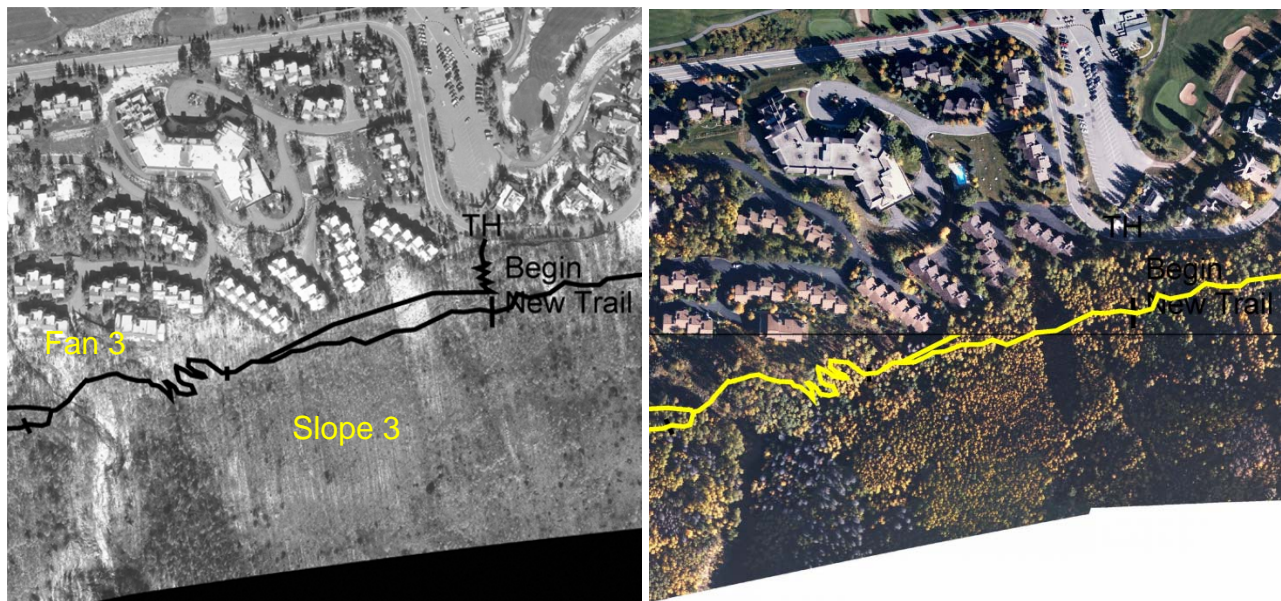
Figure 6 – 1998 & 2004 Aerials of Slope 3 and Debris Fan 3

Debris fan 3 appears to be a relatively active fan based on vegetative indicators and fan geometry. The channel has an abrupt 45 degree left bend near the fan apex and is incised about 20 feet deep. The existing trail crosses the channel below the deep incision.

Slopes 3 and 4 are adjacent and continuous slopes above Golf Lane. Slope 3 is above the existing trail and exhibits forest clearings that indicate frequent debris and/or snow avalanche activity (Figure 6). Slope 4 is above the existing eastern trailhead for the Vail Trail. Slopes 3 and 4 can produce snow and/or debris slides and rockfall above or within the colluvium. All begin at or below the prominent Minturn Formation ~ 400-500 feet above the valley. Many observations in 1984 indicated the debris slides were mixed snow and debris including entrained vegetation including aspen trees and their root systems. They often began as soil slips 1-3 feet deep, rarely as deeper rotational failures within the colluvium. In some cases they were triggered by a combination of infiltration directly from the overlying, unusually deep snowpack and piping to the surface soil at boundaries in the

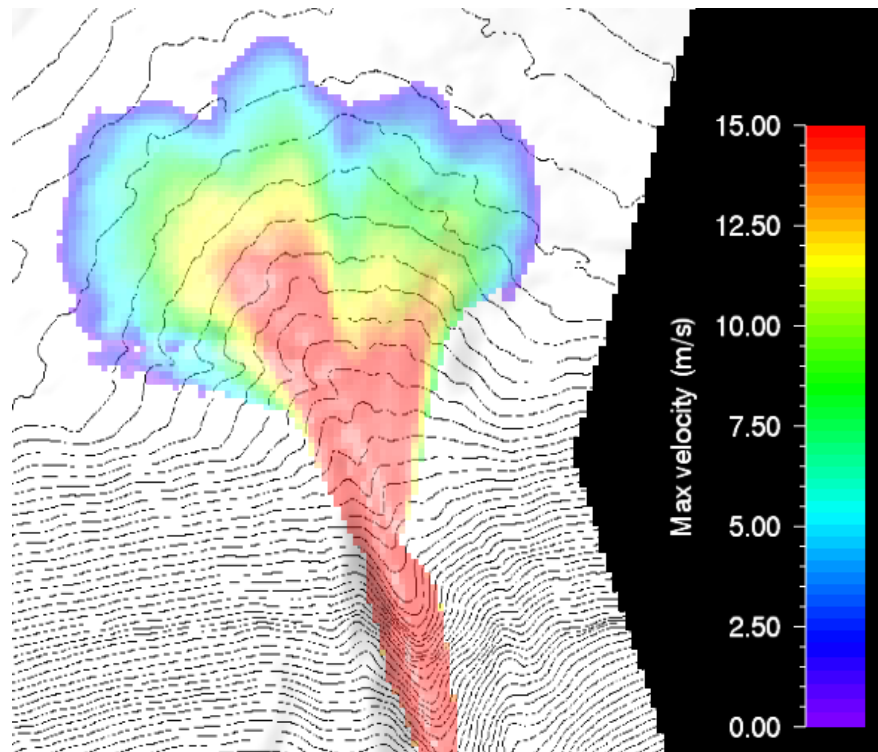
Figure 7 – RAMMS Avalanche Model Runout Prediction for 30-year Event

We applied the Swiss avalanche dynamics model, RAMMS (Ref. 9) to the Clubhouse avalanche path to evaluate the effect of 3-dimension terrain on flow paths. Figure 7 shows the model predicted runout and maximum velocities for a cold dry avalanche with an estimated return period of about 30 years.

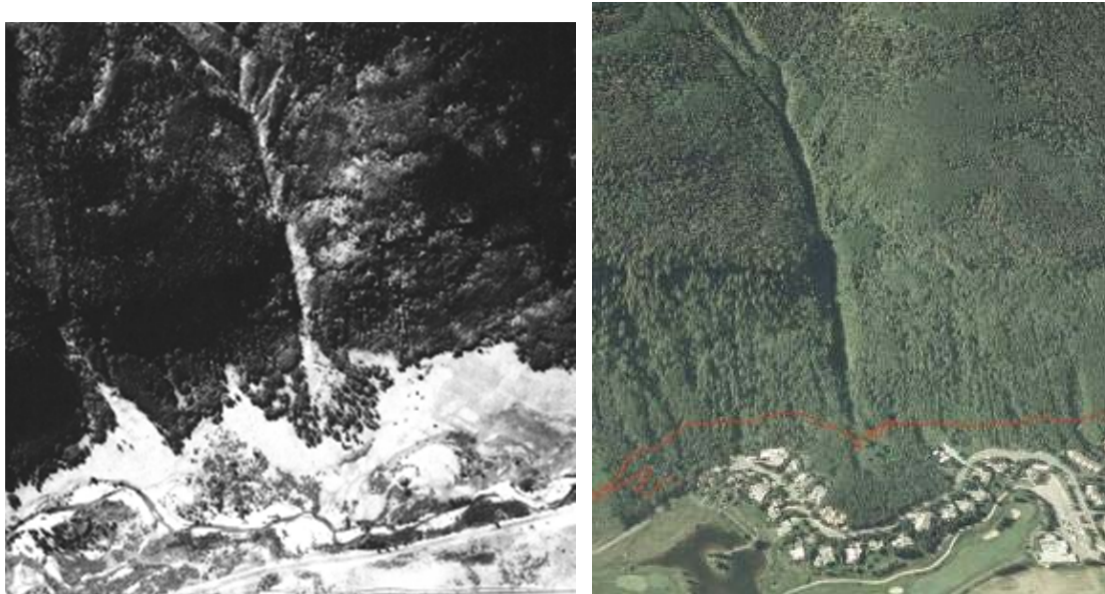
Figure 8 – 1962 & 2006 Aerials of Clubhouse Debris Fan

The Clubhouse avalanche path can reach Fan 4 in the Sunburst Drive area. This fan is exposed to low frequency high energy snow avalanches and debris flows. It was studied in 1972 by Borland (Ref. 6). He reported that the Clubhouse avalanche path has a starting zone of about 40 acres and a total vertical fall of about 1600 feet. In 1972, aspen trees in the runout zone on the alluvial fan were about 30 years old, based to tree coring. The estimated return period to the alluvial fan was 30 to 100 years.

Borland described at least six wet slides at the south end of the Clubhouse property with vertical falls of 50 to 300 feet and frequencies of 2 to 5 years.
