Vail 2010 Flood Assessment

January 27, 2011

Prepared For:
Town of Vail
Department of Public Works
1309 Elkhorn Drive
Vail, CO 81632

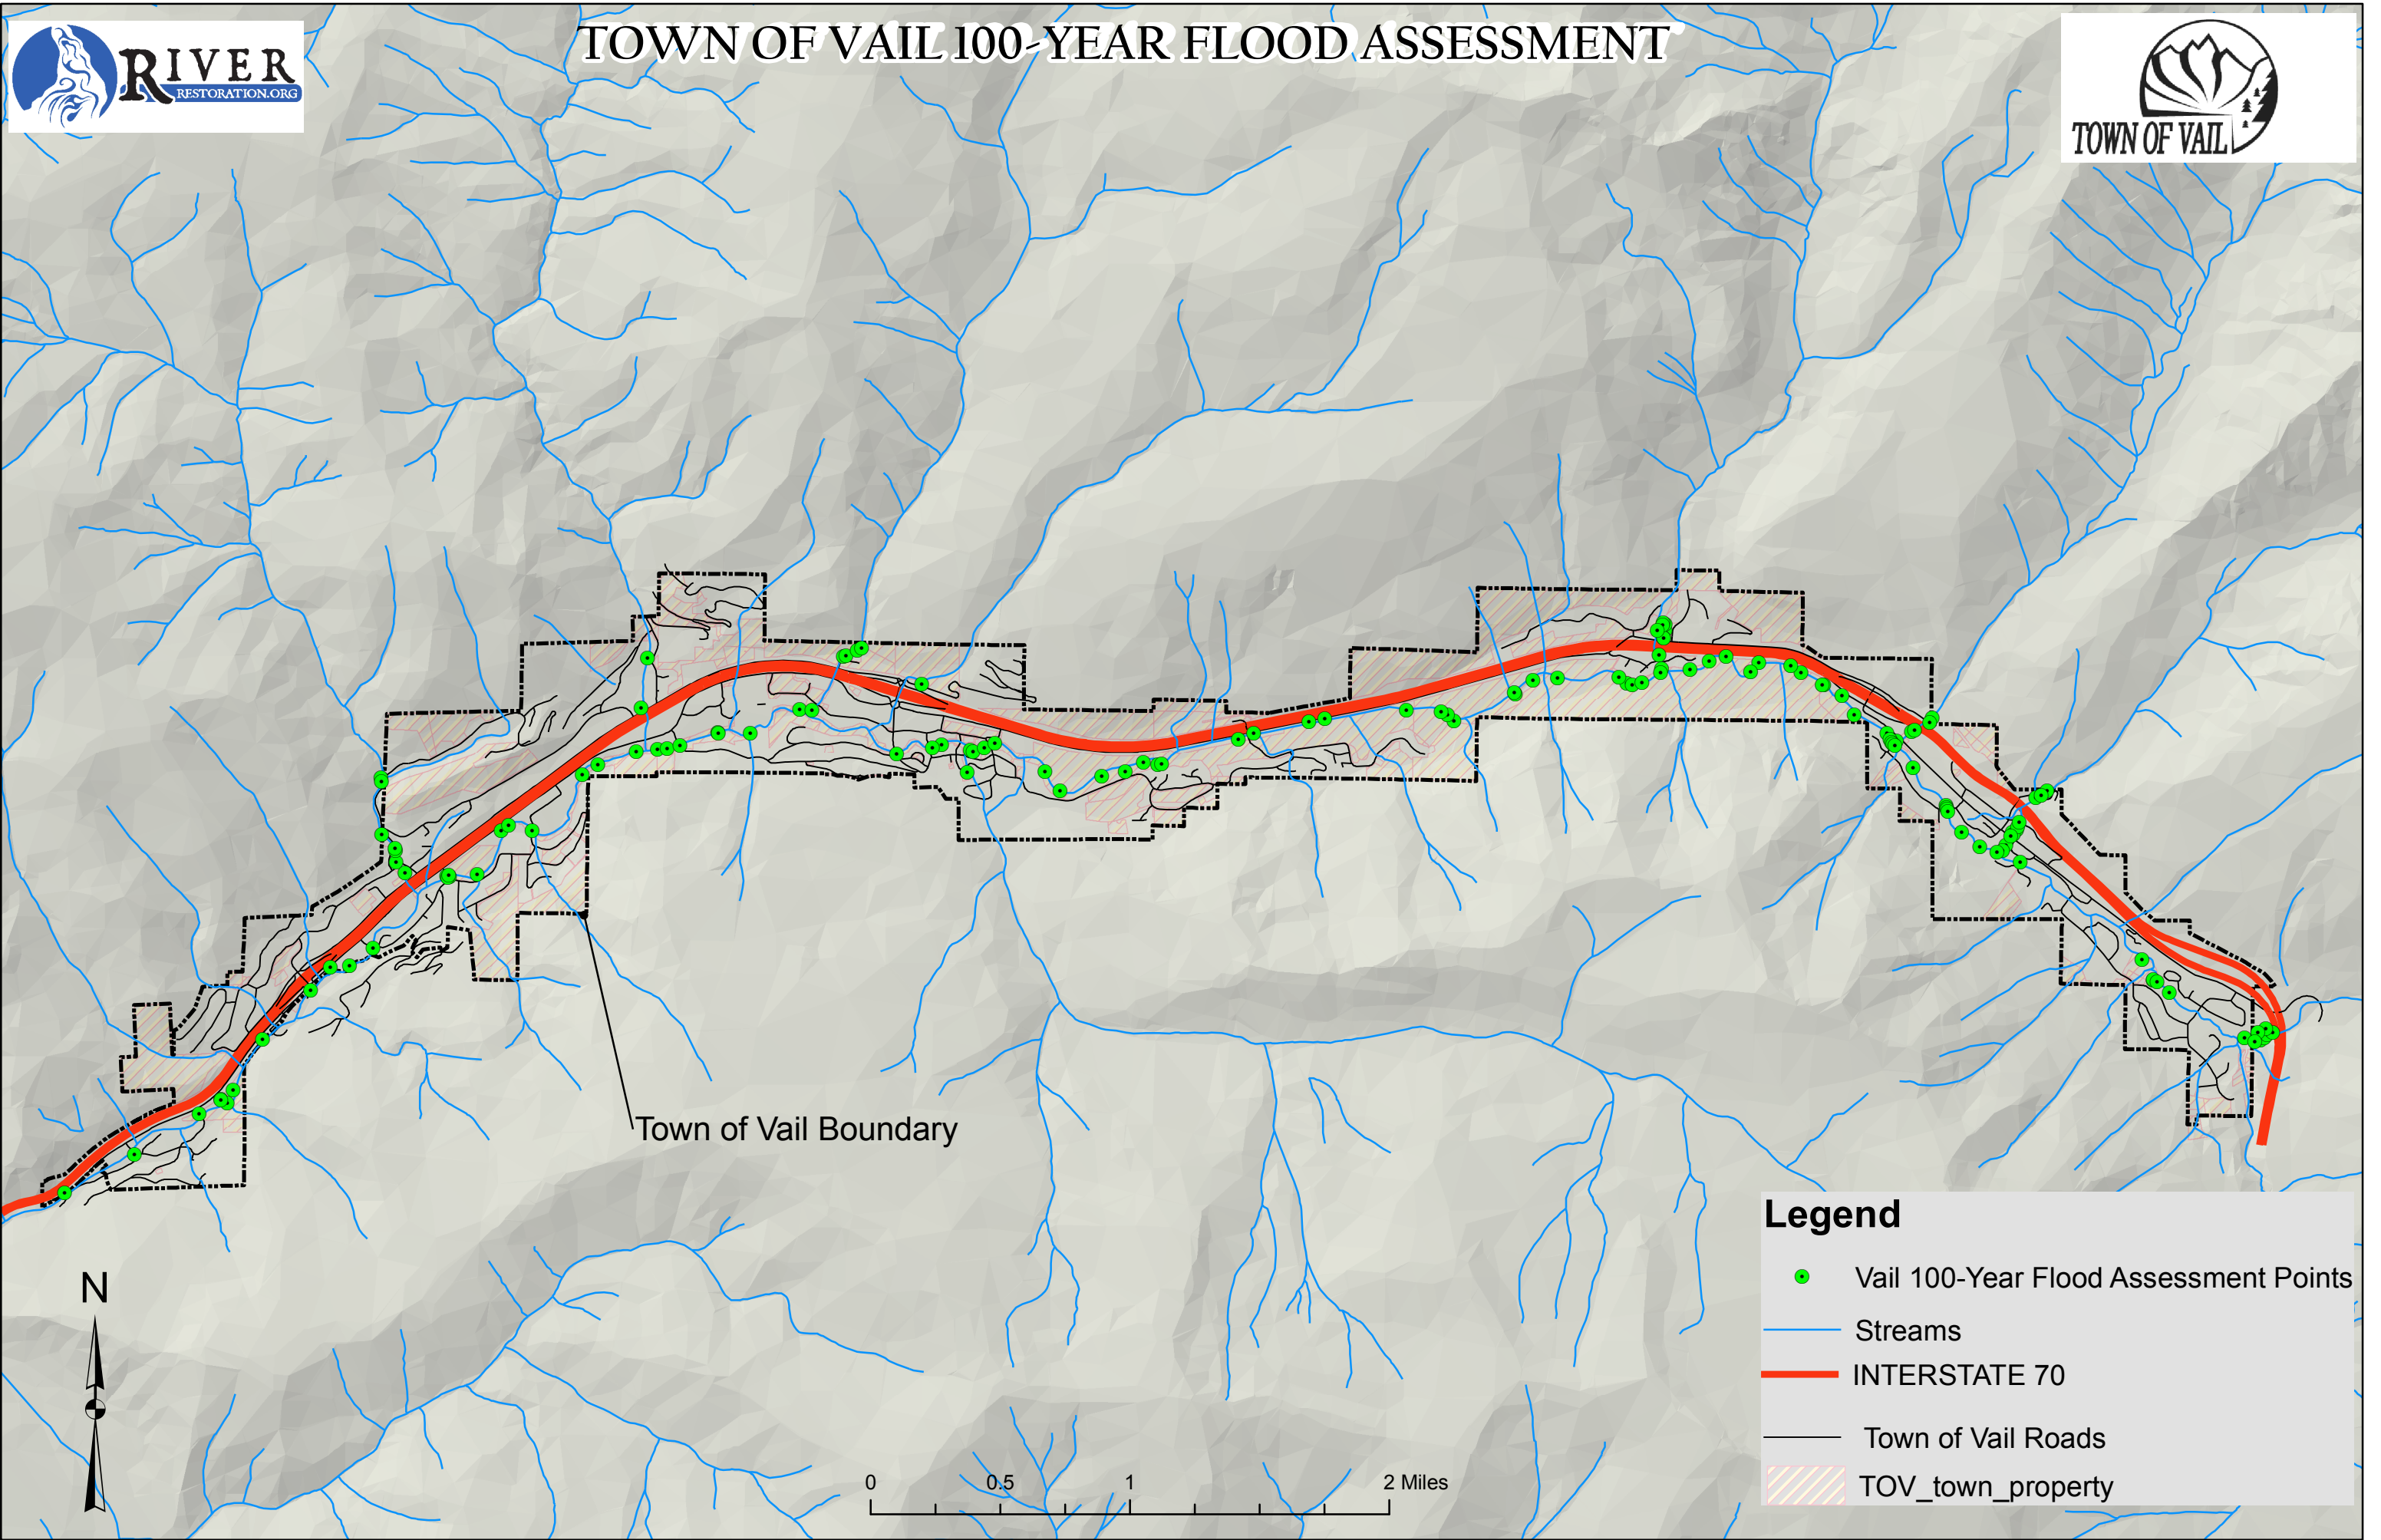
TOWN OF VAIL 100-YEAR FLOOD ASSESSMENT

RiverRestoration staff rapidly assessed damage resulting from the 2010 flood at over 58 assessment sites throughout Vail, Colorado (Appendix A). The 2010 flood event had relatively insignificant structural damage; however, multiple instabilities have resulted from the flood. If the flood had persisted for just a couple more days, it is our opinion that the structural damage would have been a magnitude (10 times) greater. Aspen Court was the only bridge completely lost to the flood; however, 8 additional crossings have been compromised and likely could not sustain another flood event. Most of the tributaries are perched above adjacent roads, development and infrastructure; overbank flooding and channel cutting occurred on these tributaries, laying the path for future floods to be more damaging. Massive sediment deposits have occurred in Gore Creek and tributaries, changing erosion patterns and reducing flood capacity. A number of channel instabilities should be repaired before the next flood event (see Appendix B for a detailed list of priorities). More detailed assessment is required to determine the specific repair method and the cost thereof.
