## 6.0 Appendix

# 6.1 EXISTING CONDITIONS PHOTOS

**GEOLOGIC HAZARDS REVIEW  
PROPOSED TOWN OF VAIL  
PUBLIC WORKS FACILITY DEVELOPMENT  
1309 ELKHORN DRIVE, VAIL  
EAGLE COUNTY, COLORADO**

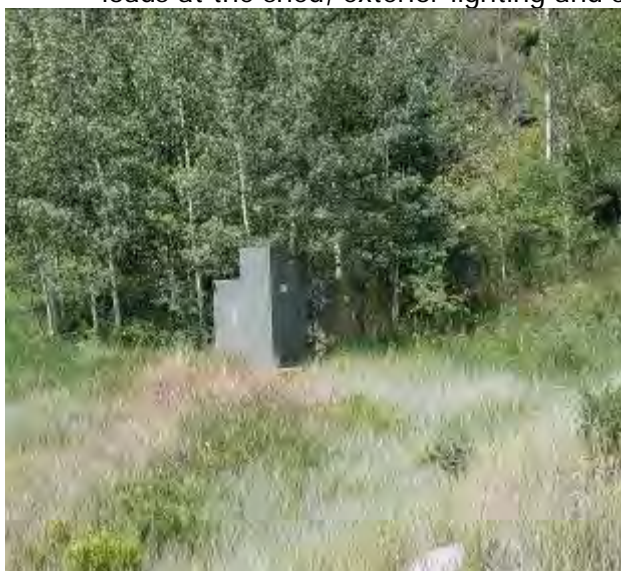
Utility transformers at northwest corner of property. These feed the Admin building and housing.

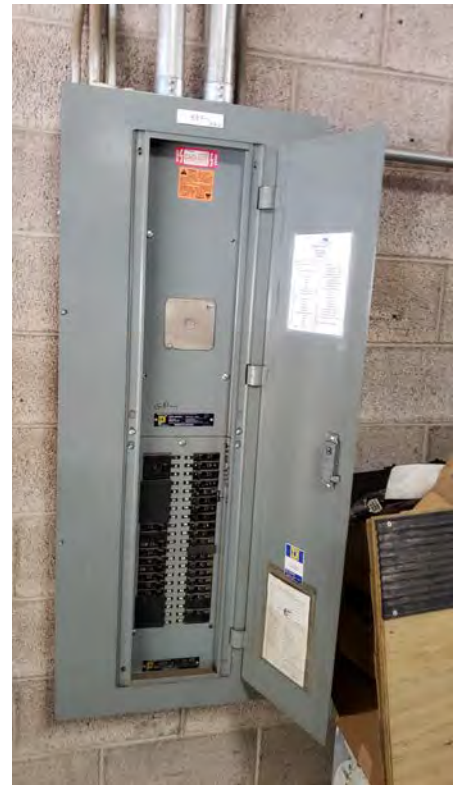
**Maintenance Building typical power panel**

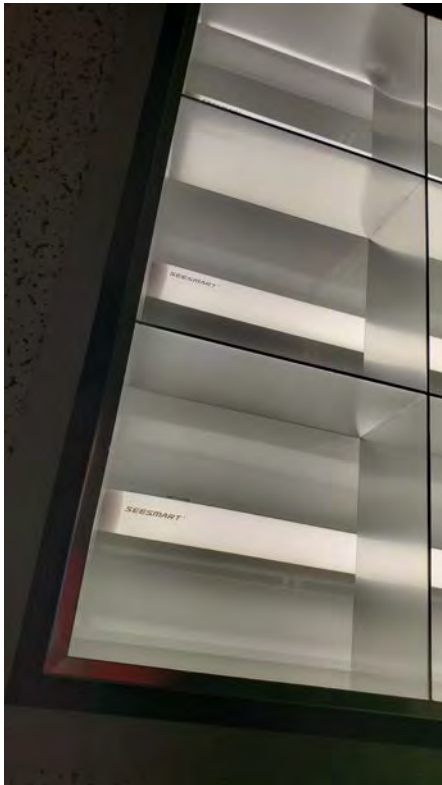
Interior lighting throughout the Administration and Maintenance Buildings are primarily a variety of fluorescent fixtures that have been retrofit with LED lamps. At the Bus Barn, east part of the Maintenance Building, new LED fixtures with motion control has been installed. Lighting control is primarily on/off switches with some lighting controlled with motion sensors. Lighting is adequate throughout the buildings.

**Maintenance and Admin Building typical  
Fluorescent fixture retrofit with LEDs**

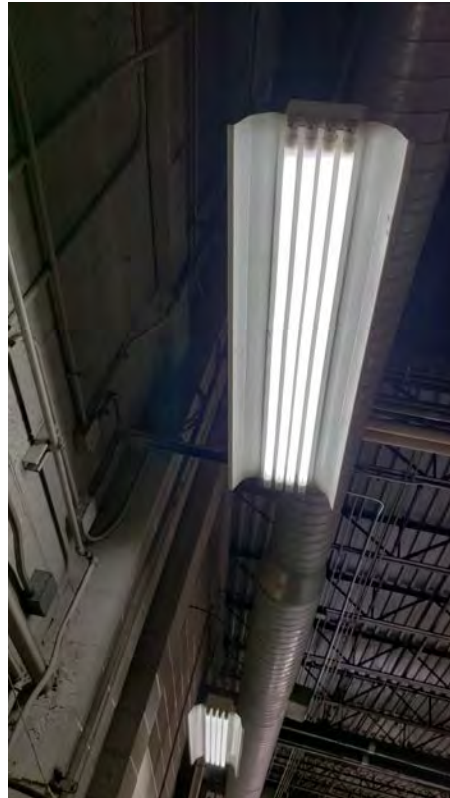
**Maintenance Building industrial  
Fluorescent fixture retrofit with LEDs**

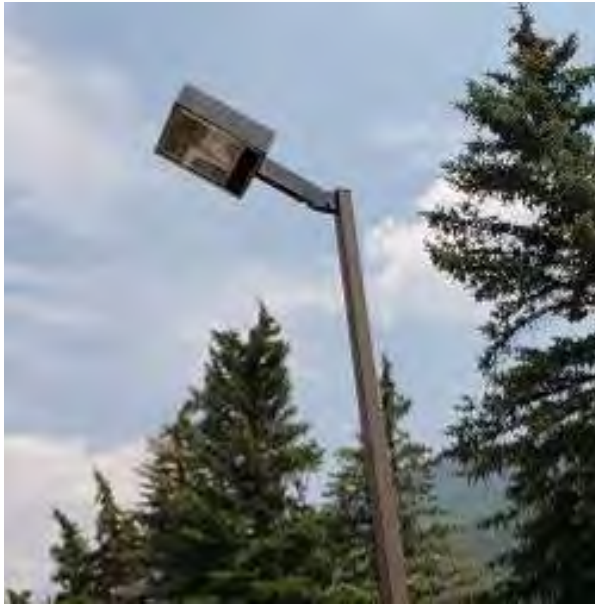
Exterior lighting at the Administration and Maintenance Buildings are pole and wall mounted area fixtures that are retrofitted with LED lamps. These fixtures are not cut off type and would not be considered Dark Sky compliant. These lights are controlled through traditional photocell and timeclocks.

**Pole mounted LED fixtures at Site**

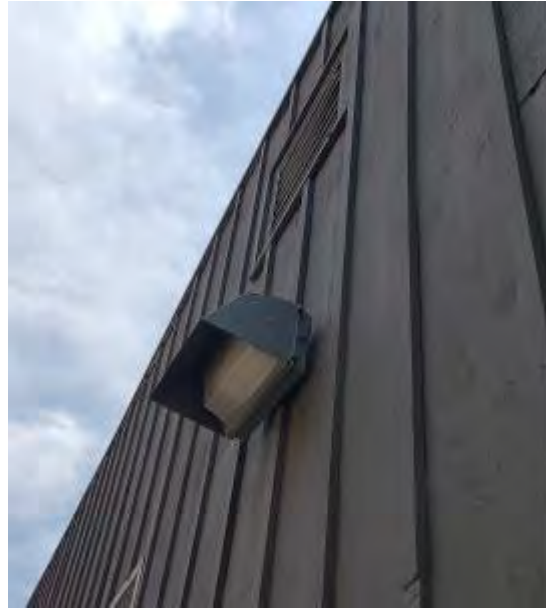
**Wall Mounted retrofit LED**

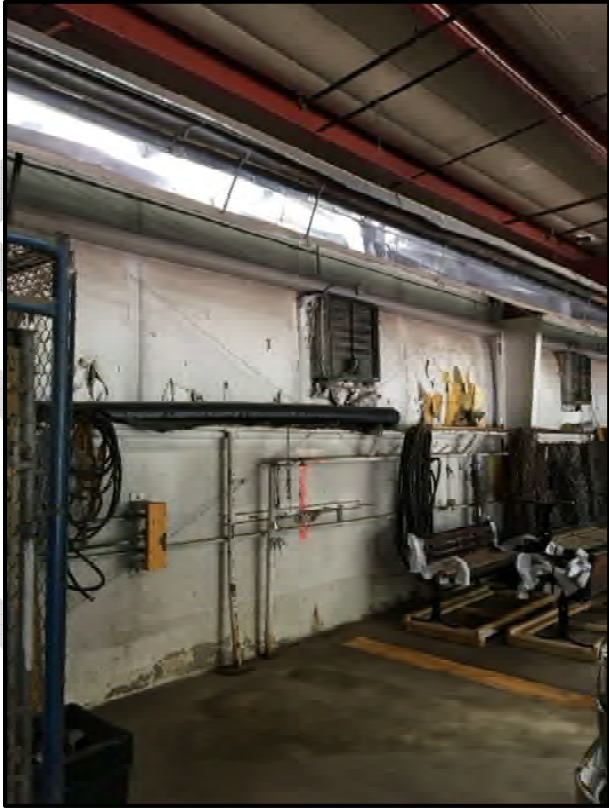
The majority of the structural framing for the metal buildings and additions was exposed. The structure for the 1996 and 2002 addition appeared to be built in accordance with the structural drawings. Each metal buildings appeared to have its own lateral system consisting of moment frames and tension only steel cross braces (Photo 2). There were locations in each building where one of the steel cross braces had been removed (Photo 3). There were also discovered locations where both cross braces had been removed (Photo 4). The lateral system for the 1996 addition appeared to be concrete masonry shear walls in each direction. The lateral load for the 2002 addition appeared to be resisted by the lateral system of the existing building as no additional bracing was provided in the 2002 drawings.

Photo 2: Tension Only Steel Cross Brace

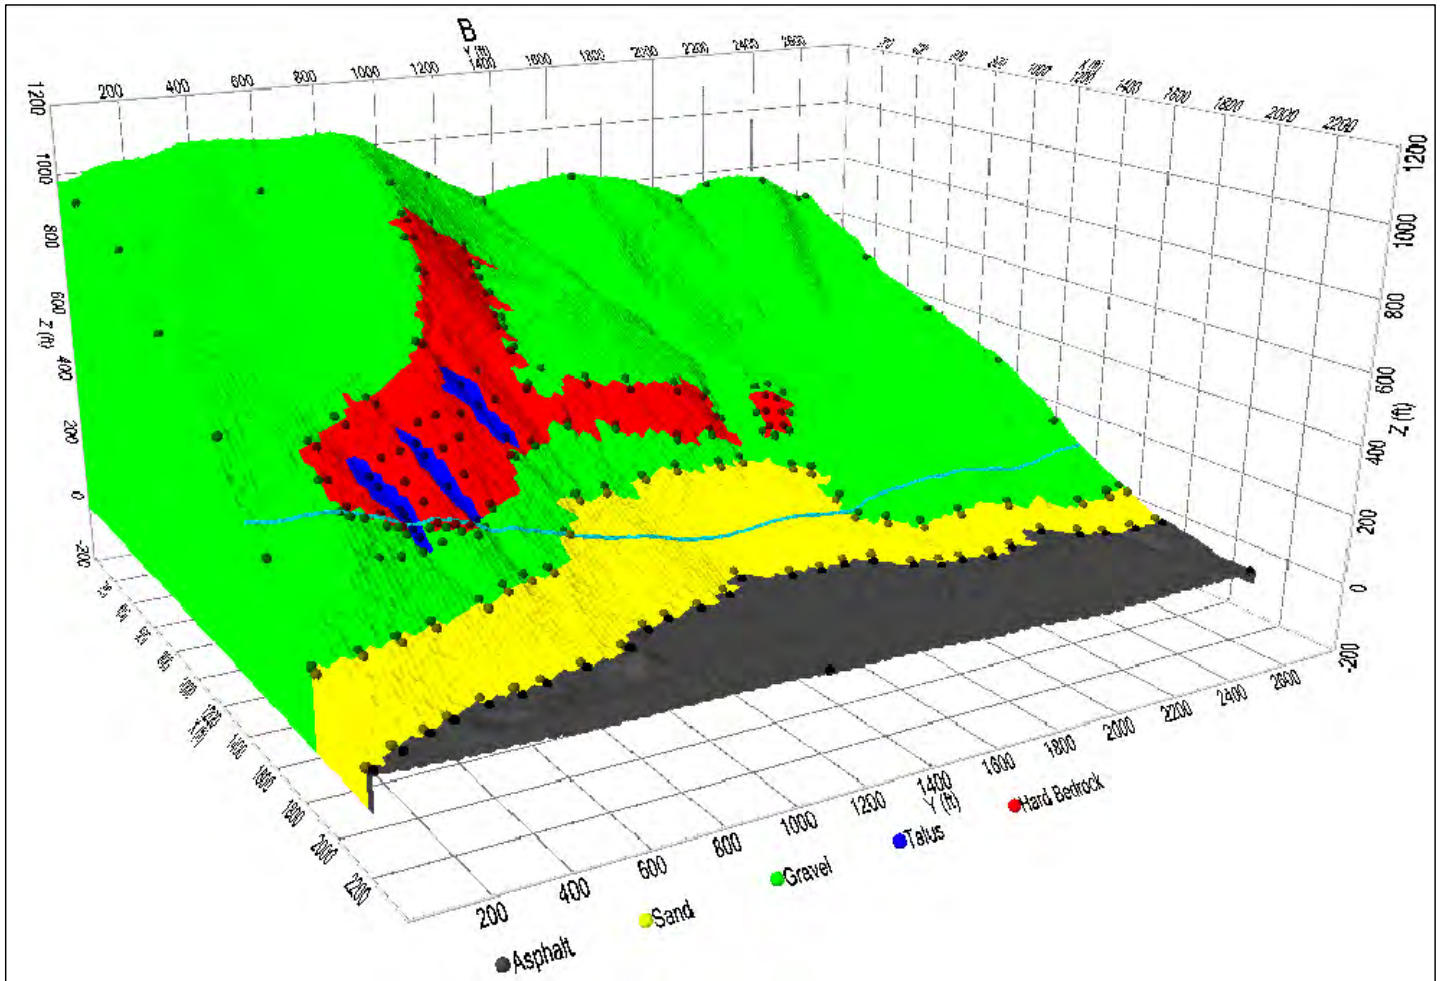
A map showing potential rockfall hazard areas is presented in Figure 2. The potential hazard consists of a rockfall source zone, a rockfall runout zone, and an area of potential rockfall paths between the source zone and the runout zone. The project site is located in the potential runout zone as shown on Figure 1.

Rockfall is an active geologic process in the lower part of the Vail valley side to the north of the project site. Without long term observations, it is not possible to develop recurrence probabilities for rockfalls from the source zones at the project site with high levels of confidence but seems reasonable to infer that rockfalls from these source zones are infrequent. The Crsp3D modeling shows that if a rockfall were to occur during a reasonable exposure time for the proposed development, it is possible that the rockfall would reach the proposed development areas shown on Figures 2, 3, and 4.
