VILLA CORTINA AND RELIGIOUS FOUNDATION TRASH

BANK OUTDOOR SEATING AREA WITH CRUSHED GRANITE

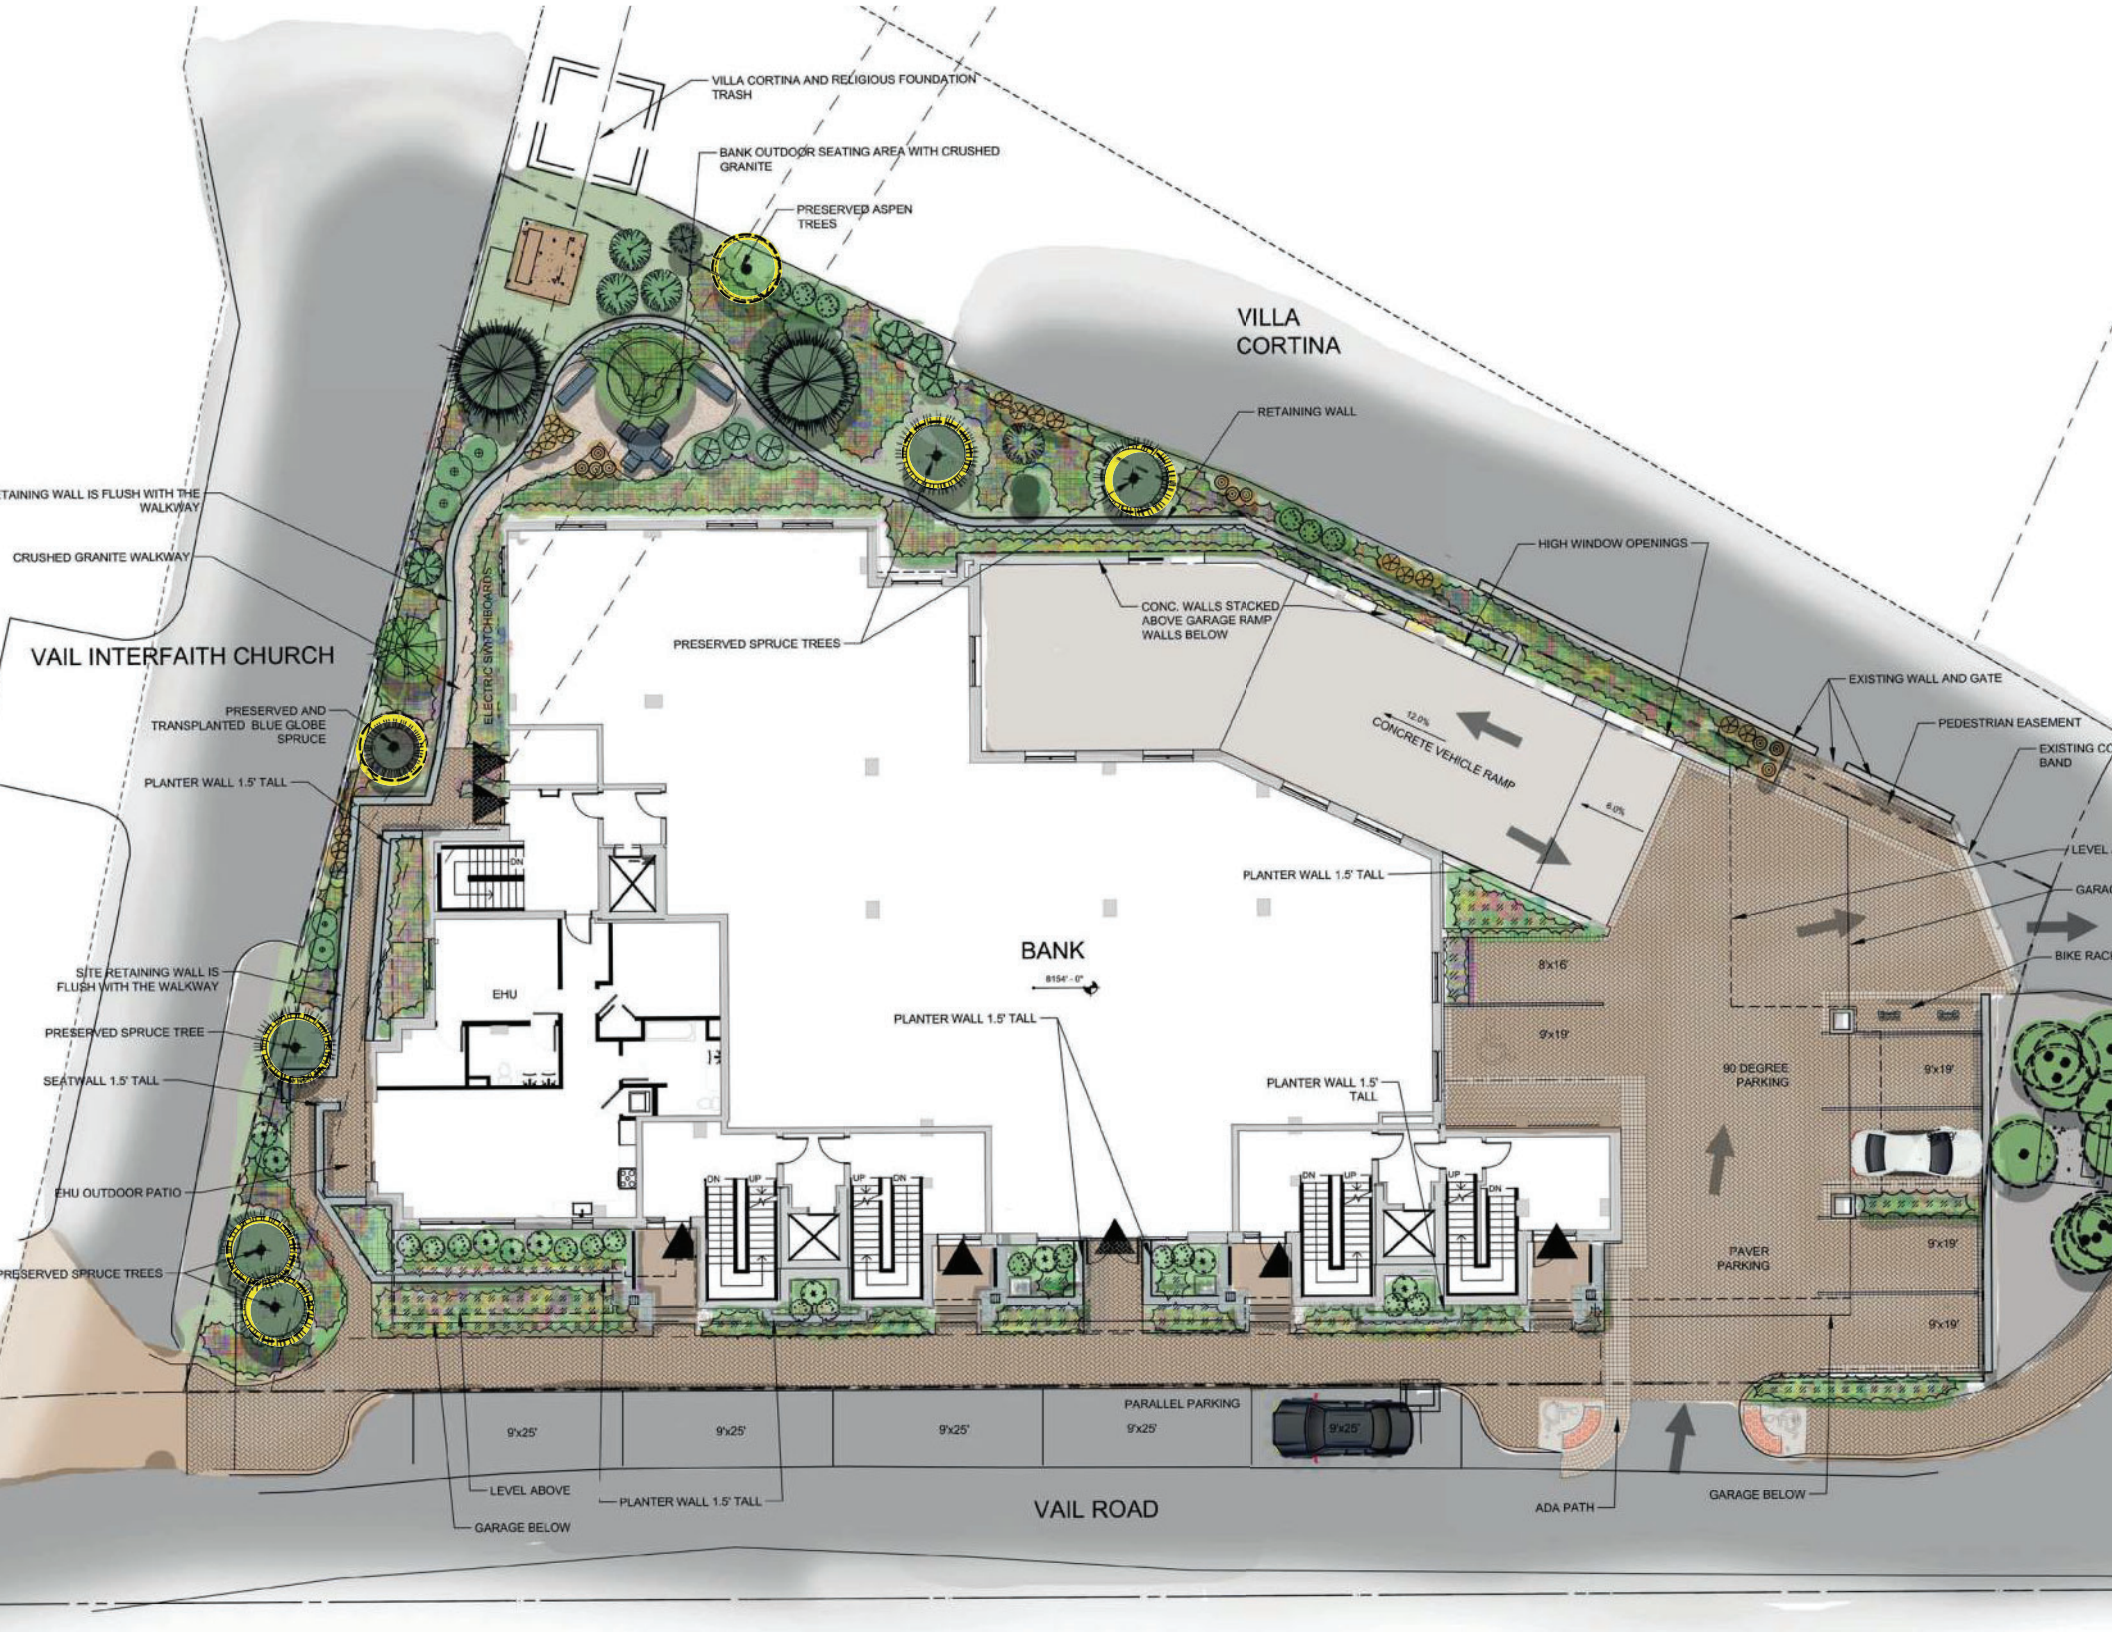
PRESERVED ASPEN TREES

RETAINING WALL

RETAINING WALL IS FLUSH WITH THE WALKWAY

CRUSHED GRANITE WALKWAY

CONC. WALLS STACKED ABOVE GARAGE RAMP WALLS BELOW

EXISTING WALL AND GATE

PEDESTRIAN EASEMENT

PRESERVED AND TRANSPLANTED BLUE GLOBE SPRUCE

PLANTER WALL 1.5' TALL

SITE RETAINING WALL IS FLUSH WITH THE WALKWAY

SEAT WALL 1.5' TALL

EHU OUTDOOR PATIO

90 DEGREE PARKING

BIKE RACK

PAVER PARKING

PARALLEL PARKING

VAIL ROAD

ADA PATH
